STOCK CONDITION SURVEYS OF BUILDINGS AT CHICHESTER, BRINSBURY AND CRAWLEY

June 2018

Chichester College

Ridge and Partners LLP

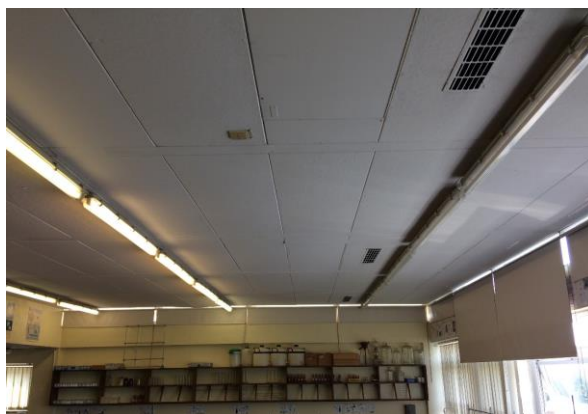
There is an internal room between classrooms A33 and A34, but none of these rooms have fire detection. It would be sensible to have fire detection within these rooms so that users of the internal room (no vision panels) are alerted in the event of a fire, although there are two directions of escape from this room. A334 and A335 are biology lab's equipped with gas supplies to workstations, for Bunsen burner attachments, although do not benefit from fire detection or fire doors to form separate compartments.

Laboratory with no fire detection

Due to the foregoing, we recommend that a detailed fire risk assessment and fire compartmentation survey is undertaken for the biology labs and entire second floor. Additional precautions are likely to be required.

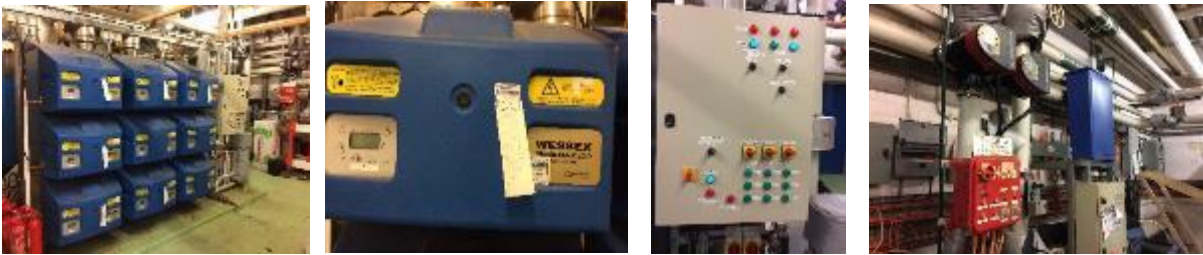
Existing gas fired Modular Boilers, Control panel and zone 3 htg variable speed pumps

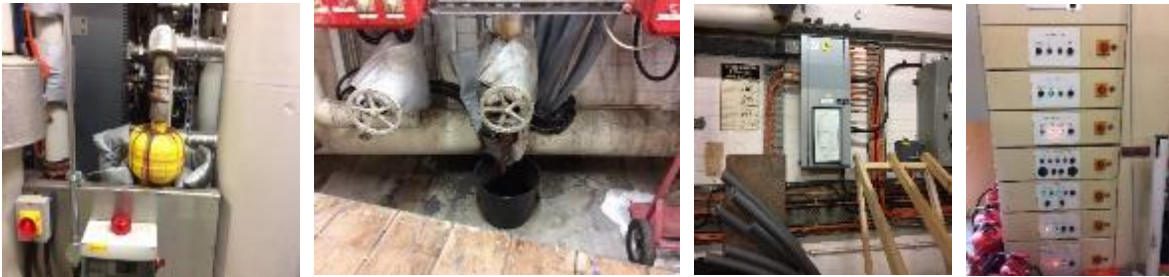
Plant and valve leaking, DB and MCCP.

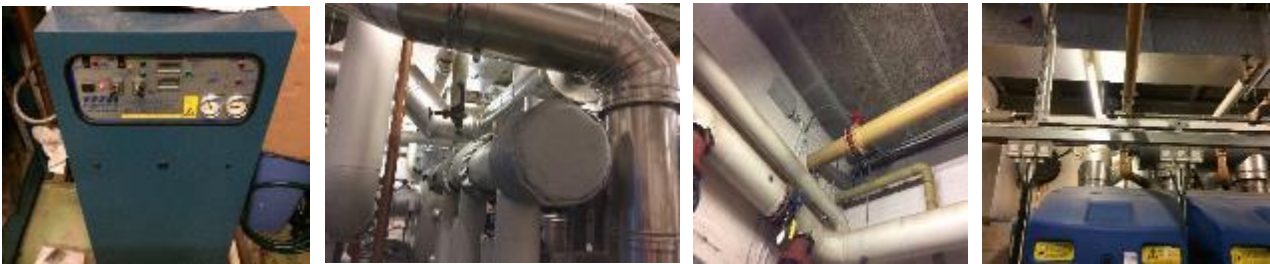
Existing pressurisation unit, flues, automatic gas shut off valve and gas detection over boilers

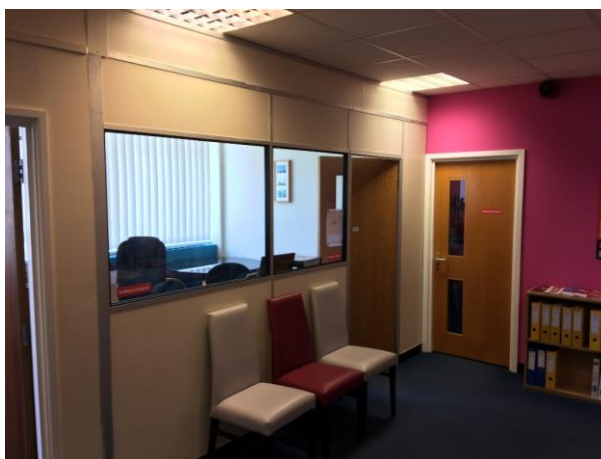
- 4th floor escape stairwell fire doors were wedged open
- 2nd floor cross corridor door set (next to 115A) is not fire rated
- B105 has 5 internal offices which are not fire rated but do benefit from vision panels and smoke detection. However, one of the offices is missing its smoke detector and this should be replaced/ repaired.

Overview of five internal offices, one with missing smoke head

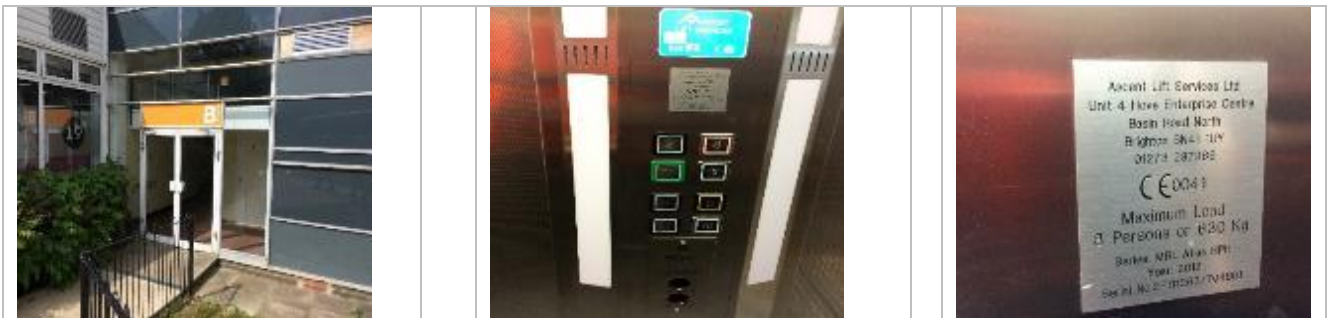
Block B, Lift.

There is a lift which serves all floors and is in good condition. Access to the roof was not possible at the time the survey was carried out. The roof does house main extract plant for the newly refurbished Kitchen.

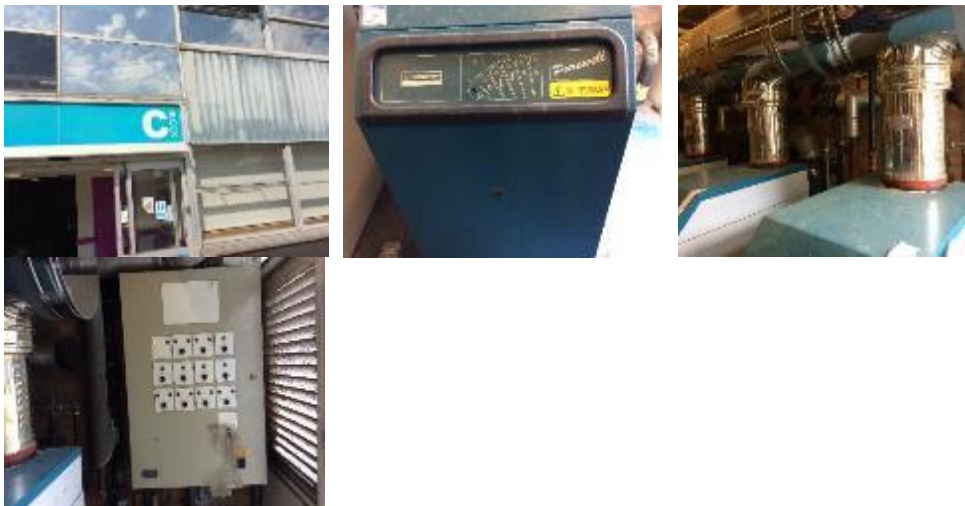
Heating is provided via the existing 4Nr LTHW Hamworthy Purewell gas fired boilers, providing LTHW to Radiators and natural convectors. The existing boilers and associated pumps, controls etc are due for replacement due to continuing issues. At present they are all shut down and decommissioned. The condition of the plantroom plant and equipment is poor. The system is open vented, and the F&E tank is located at high level within the top floor of the building. The proposed new system will possibly be pressurised.

C Block, Existing Boilers and MCCP

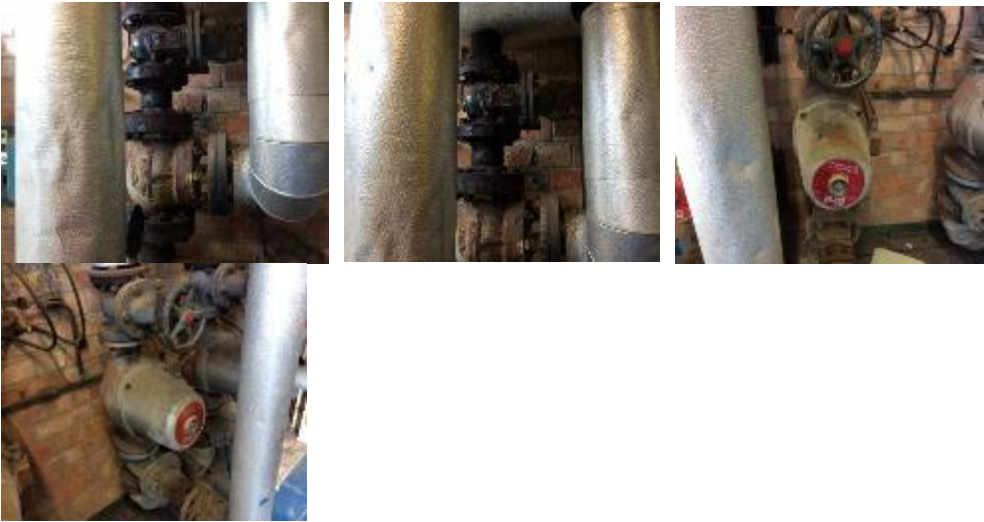
Existing Htg Valves, pipework and pumps within the plantroom. Condition poor

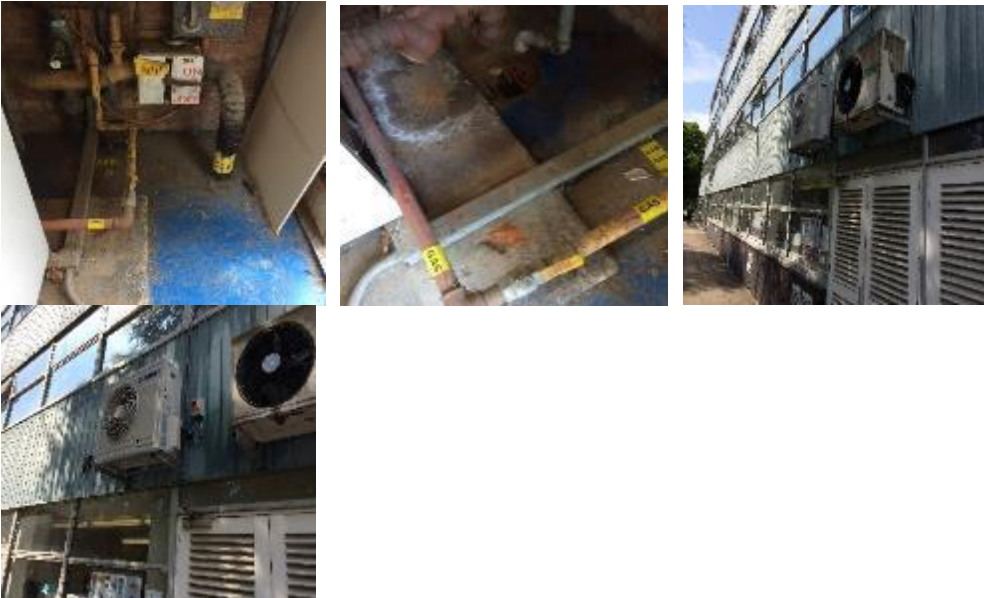
AC is provided to the Print Room, via splits. 2Nr external condenser are mounted at HL, one is near its expected life and is in poor condition and should be renewed.

Existing gas incoming main, gas valve and pipework, existing external condensers, one in poor condition.

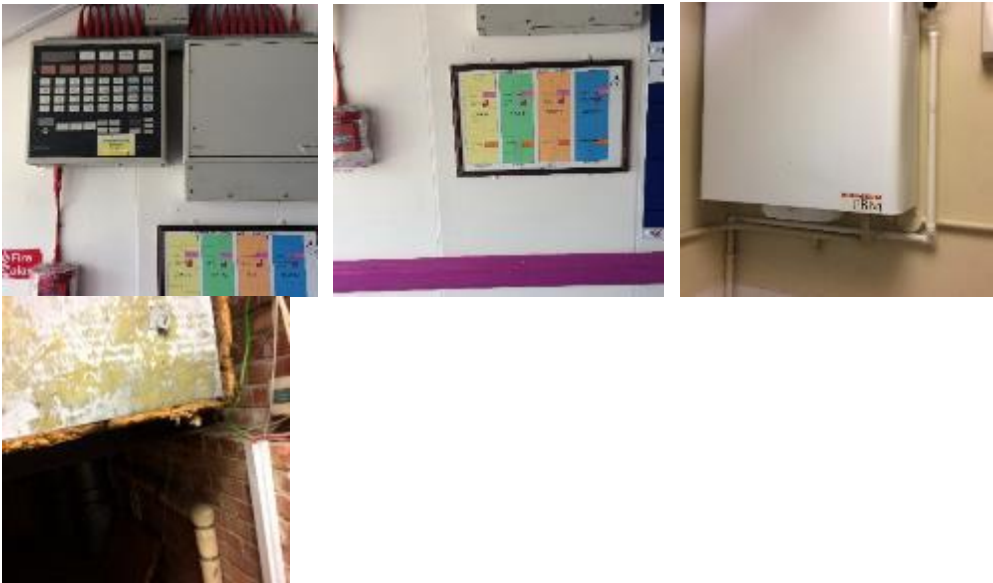
General cold water down service is provided from a cold-water storage cistern on top floor at high level. In poor condition.

Existing FA panel and zone plan, existing HWS & CWS cistern

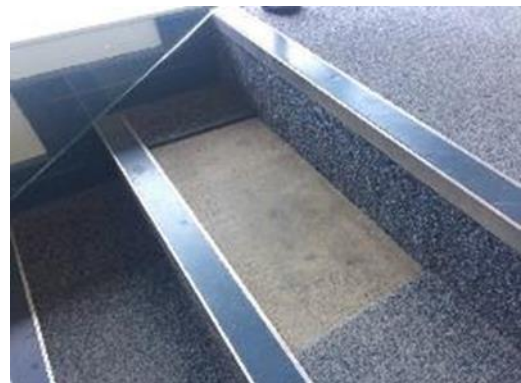
Stairs are generally in good condition but missing carpet tile to nosing area of tread of one stair causing trip hazard.

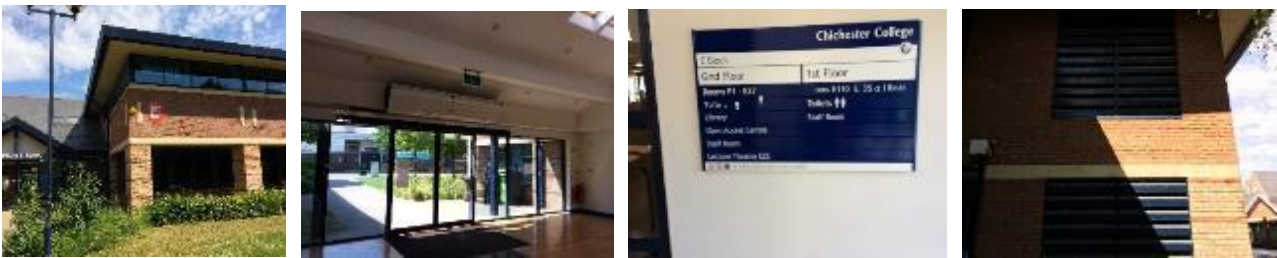
E Block main entrance and Chiller plant louvres

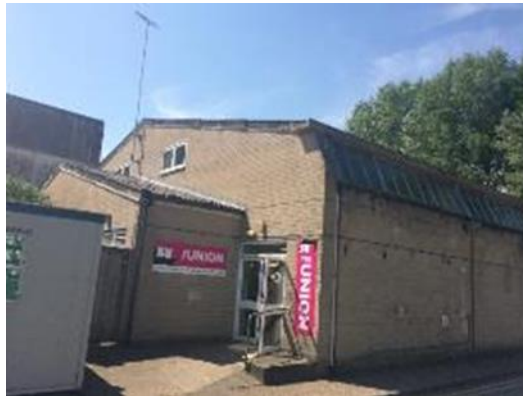
No major structural defects were noted, although some minor cracking was noted and should be monitored. Pitched fibre cement sheet roof noted to be in poor condition with evidence of some water ingress issues. Mansard/north light type window detail to side elevation, also noted to be in poor condition.

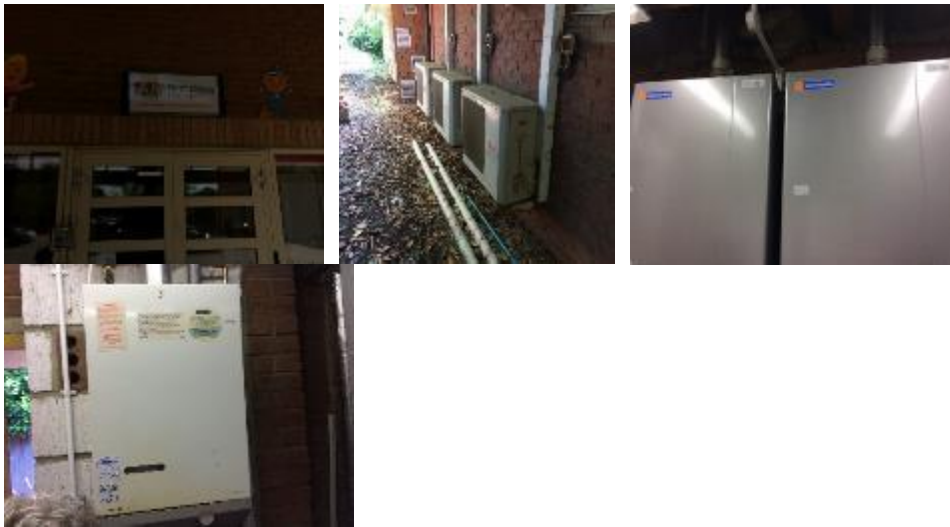
Existing external condenser units, gas fired wall hung Hamworthy boiler providing underfloor heating and Potterton wall hung boiler providing the LTHW to the Megaflo hot water heater.

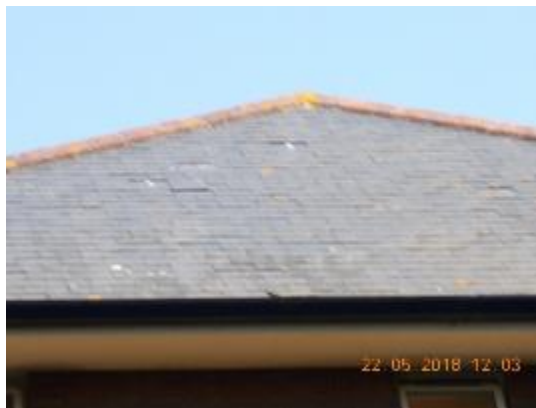
No major structural defects were noted. The roof has some slipped tiles and is in need of ad-hoc spot repairs, but overall fair condition.

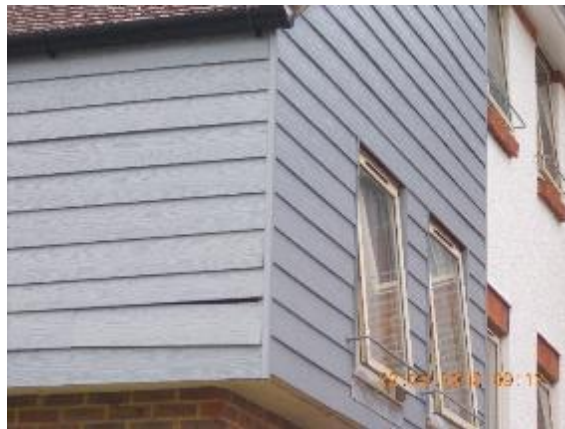
External walls are a mixture of different wall finishes noted, cladding, render and pointed brickwork all noted to be in good order, with the occasional defect such as the slipped board seen in the picture below.

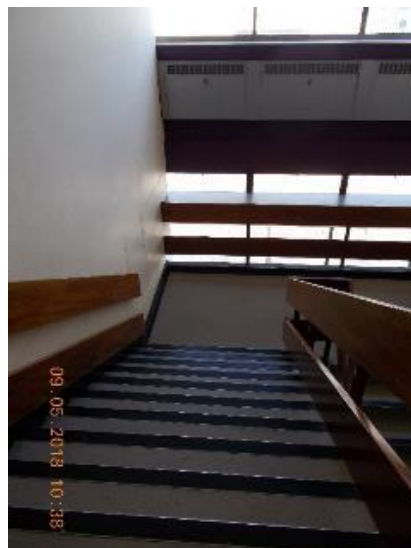
The stairs appear in a good/reasonable state of repair with some normal wear and tear evident. Note that the balustrades on this stair are greater than 100mm and consequently do not meet current Building Regulation standards.

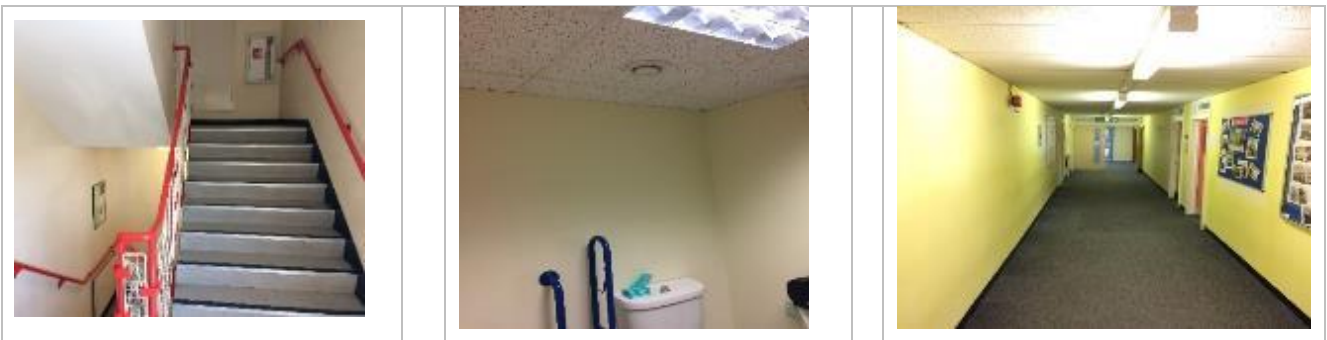
Typical stair well, disabled toilet extract ventilation and corridor

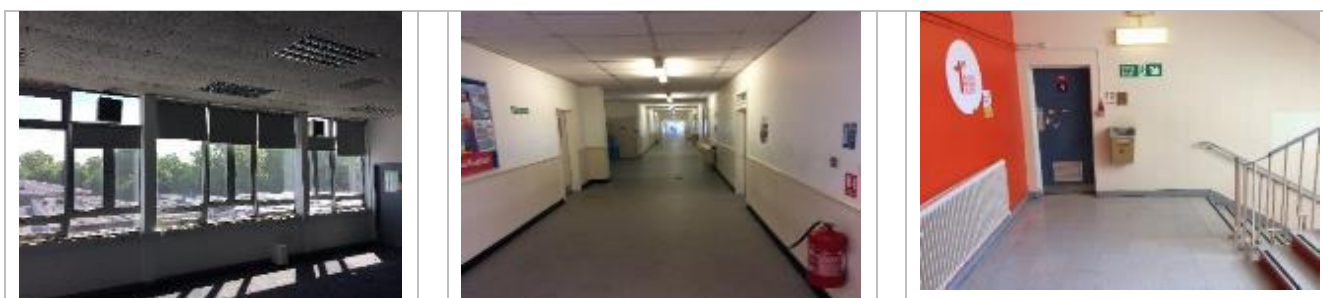
Typical classroom, corridor and stairwell, lighting, htg and FA call points

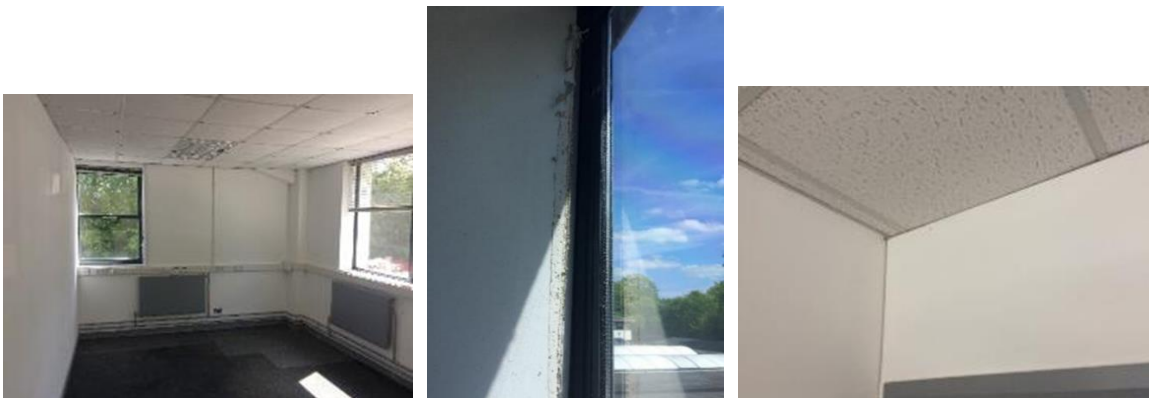
Internal partitions to new IT suite crudely installed over electrical sockets and creates a room within room, needs urgent attention.

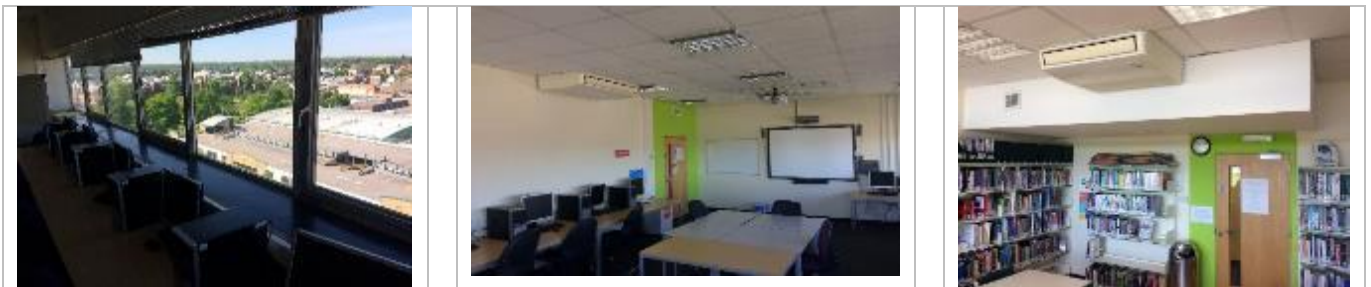
Typical tower classroom dado trunking for small power, split AC unit and perimeter Htg

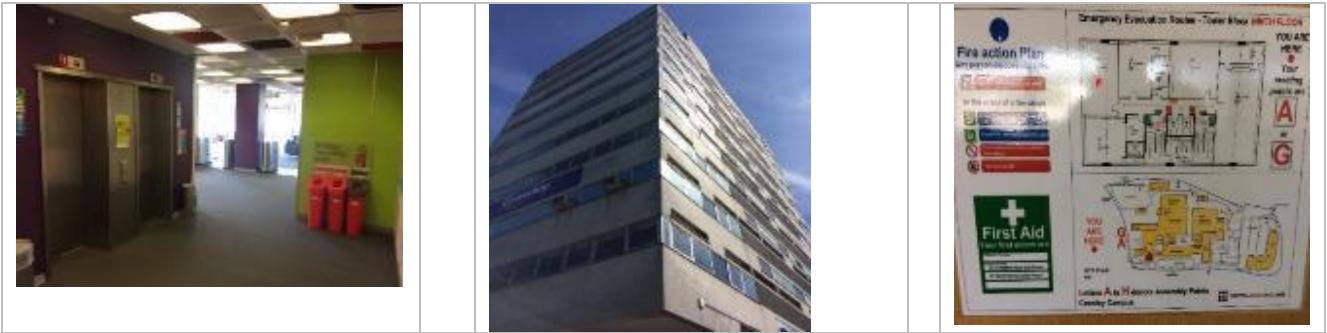
Lift lobby and external areas.

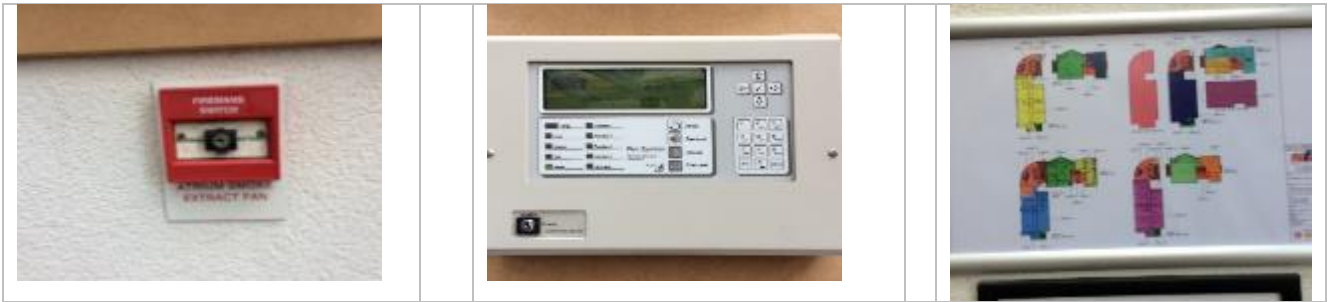
Fire safety system and atrium smoke fan control.

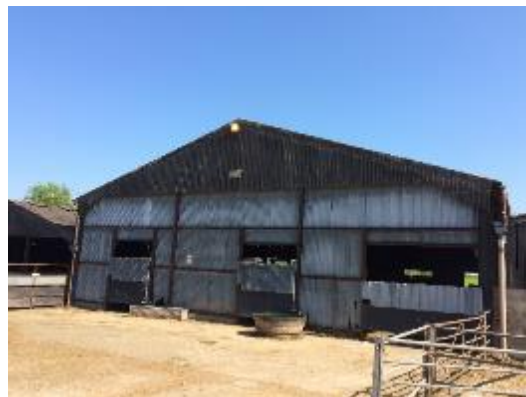
Fibre cement sheet roof in fair condition.
