STOCK CONDITION SURVEYS OF BUILDINGS AT CHICHESTER, BRINSBURY AND CRAWLEY

June 2018

Chichester College

Ridge and Partners LLP

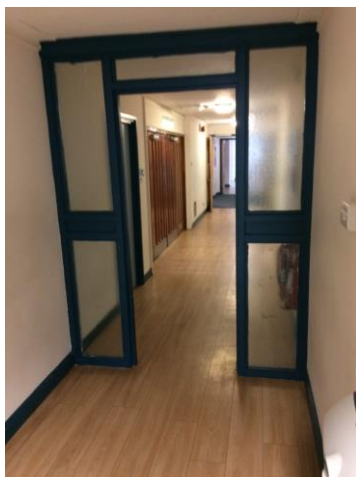
Cross corridor door set absent

Due to the foregoing, we recommend that a detailed fire risk assessment and fire compartmentation survey is undertaken for the biology labs and entire second floor. Additional precautions are likely to be required.

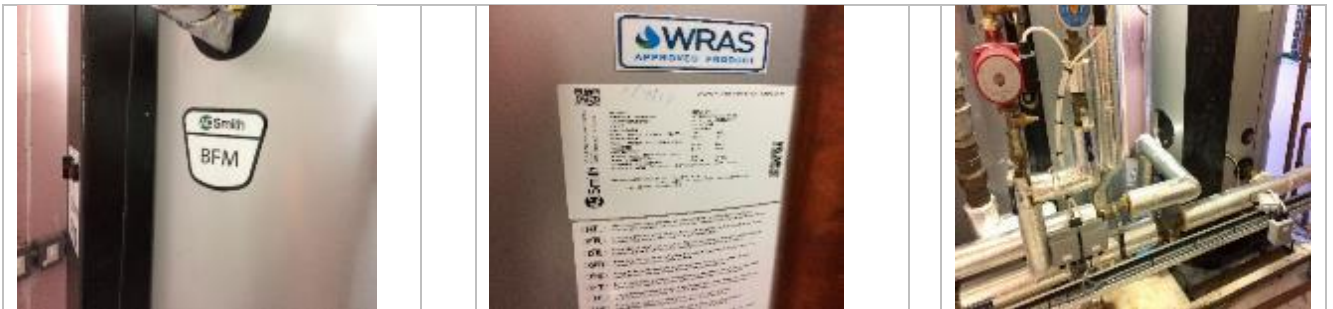
Hot water is provided by 3 number AC smith 75kW 253 litre direct gas fired conventional flue water heaters, which are located on the first-floor plantroom. One of the water heaters was leaking and is due for renewal.

Hot water Gas fired Water Heaters & HWS secondary return pump

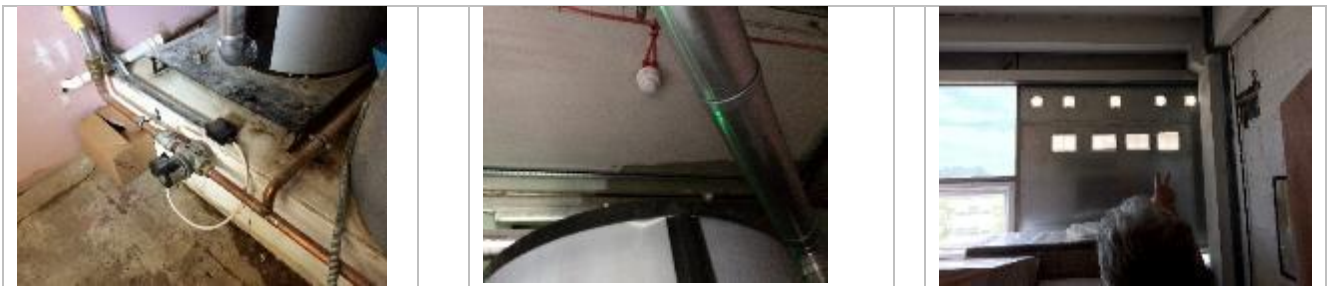
Gas shut off valve, fire detection & ventilation for combustion air.

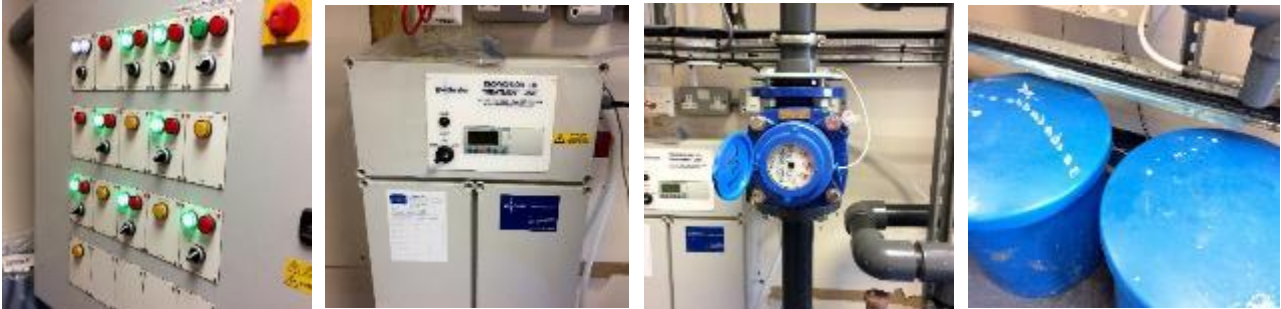
The main pumps are in another Plant area where there is a Dioxychlor 111 water treatment unit for Legionella control, together with pumps and main headers. This is all in a fair condition.

MCCP, Legionella treatment plant

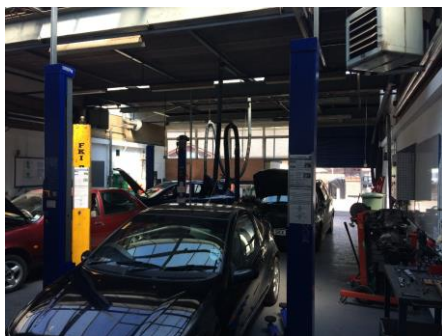
The workshops comprise car mechanics, welding facilities, and a beauty salon. There is fire detection in the corridor but not in the workshops, which is concerning due to the high-risk activities and fuel sources. Furthermore, most of the rooms do not benefit from fire door sets, but do have two means of escape; fire extinguishers are also provided. Specific risks identified per room are as follows:

No fire detection within motor vehicle workshop

Due to the foregoing, we would recommend that a full fire risk assessment of the building is carried out, as a matter of urgency, which will produce a list of required corrective actions.

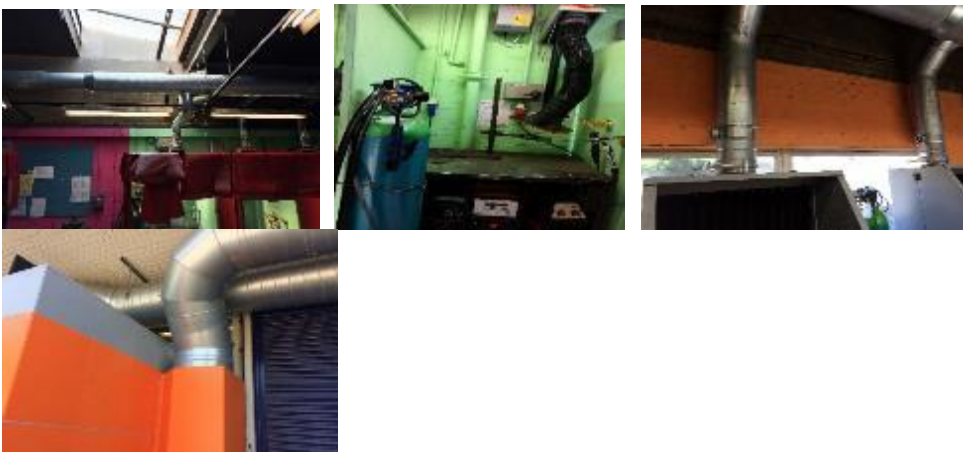
Welding booth extract, forge extract and recirculation ventilation unit.

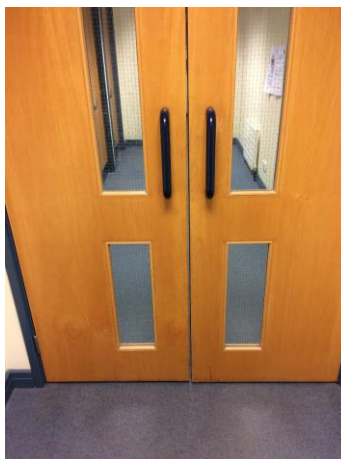
The library is complete with multiple exits, fire doors, a disabled stair lift, air conditioning and mechanical extraction in the WCs. The first floor cross corridor fire door set near room 118 was noted to have too big a gap between the double doors, rendering the smoke seals and intumescent strips ineffective in the event of a fire. In addition, the older original doors on the first floor did not benefit from intumescent strips or smoke seals.

Visible gap between cross corridor door set

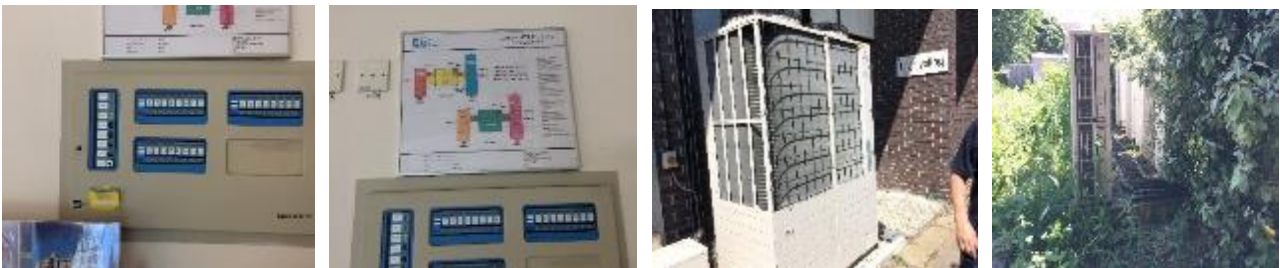
FA panel and zone plane, external air cooled condensers.

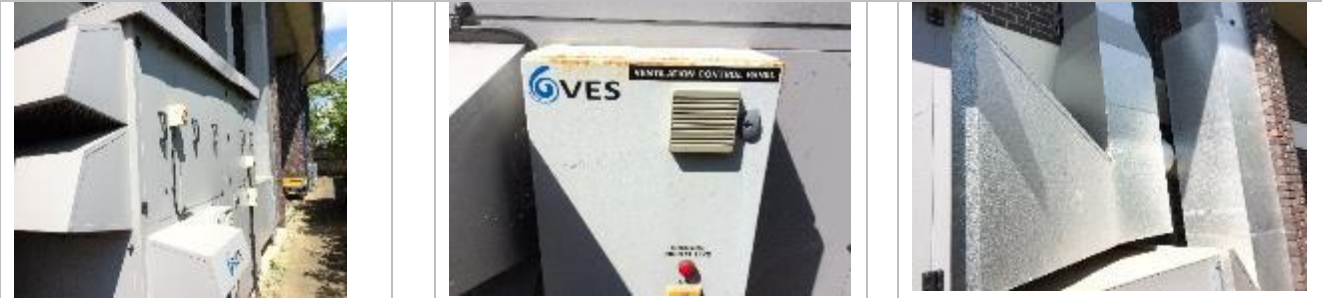
External heat recovery air handling unit

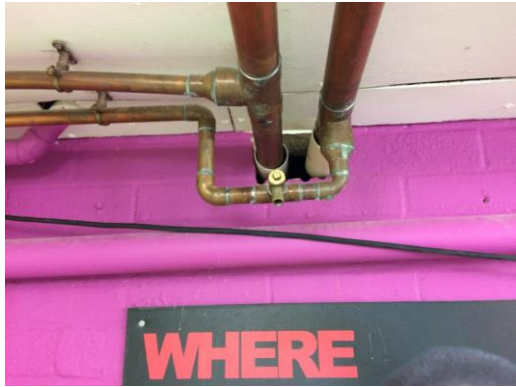
The ground floor union room has several service penetrations through solid walls, which are not fire stopped. Mechanical ventilation is not provided and the structure is heated by old fashioned gas fired hot air blowers.

Service penetrations through common room solid walls

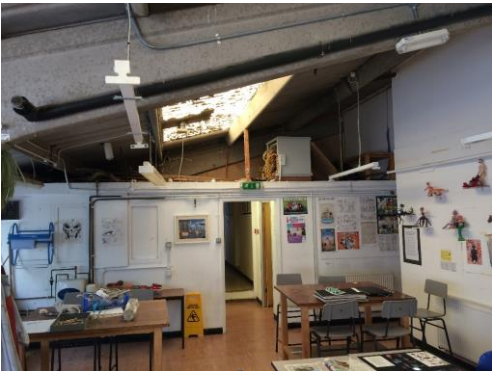
Example of first floor general condition

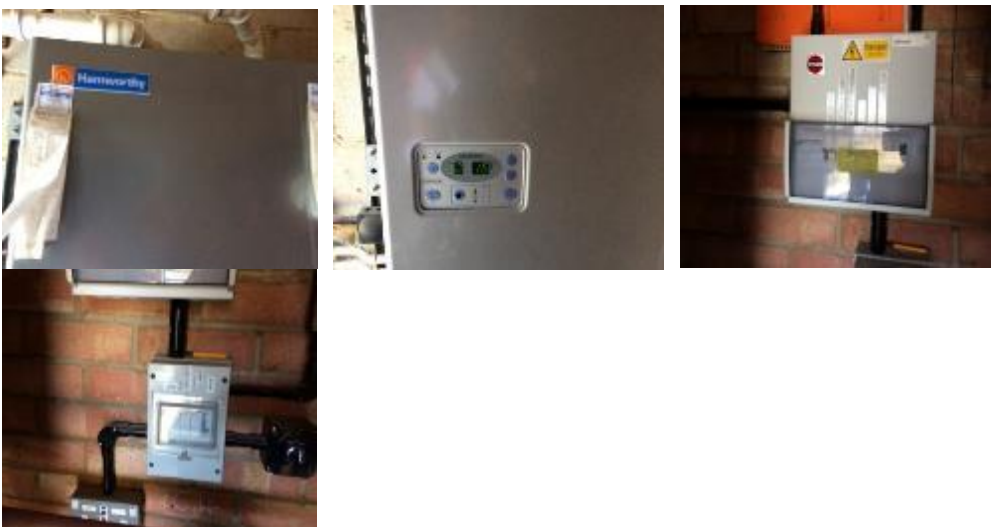
Existing wall hung gas fired LTHW boiler, electrical consumer unit

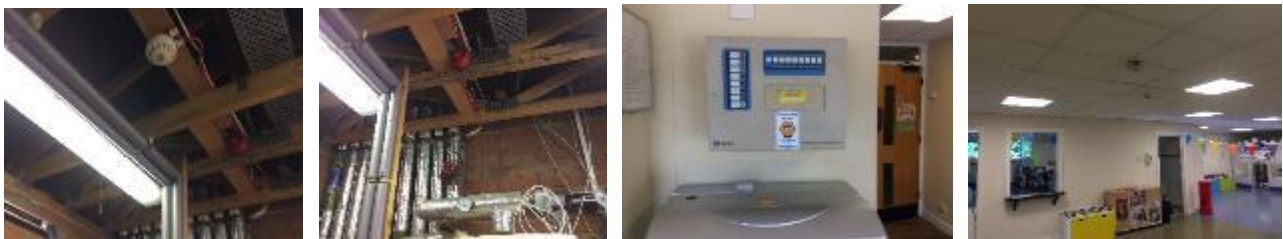
Existing FA heat/smoke and sounder, security system and classroom fire heat/smoke detector.

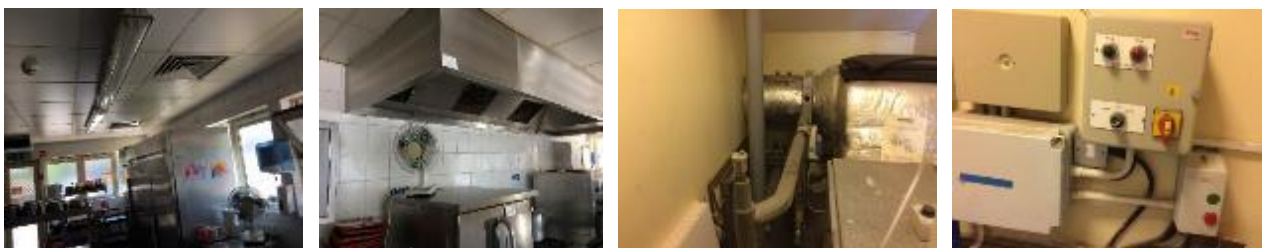
Existing kitchen extract hood and lighting, FA, AHU and controls

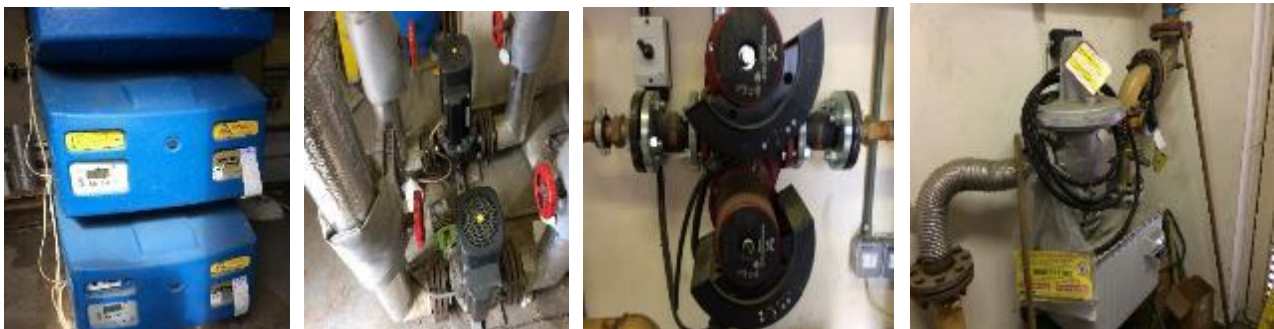
LTHW heating is provided by 3 Nr modular gas fired Wessex moduMax 110 boilers approx. age 10/15 years and are in a fair condition.

Existing modular boilers, heating pumps and gas meter.

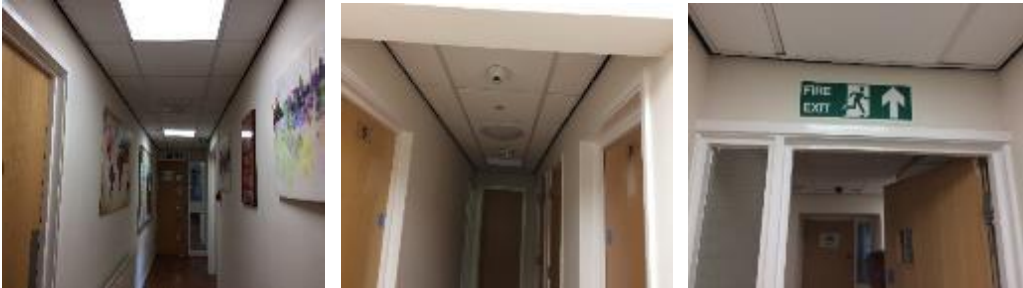
Typical corridor Lighting, FA and Fire detection

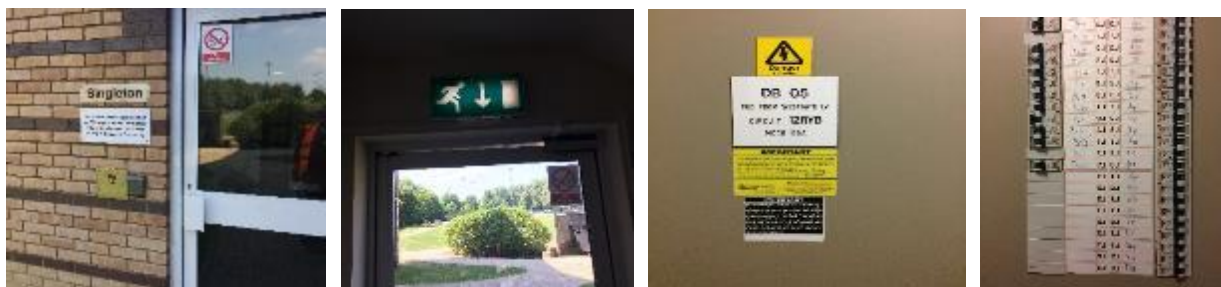
Typical security entry key pad, Fire escape sign, DB and ways

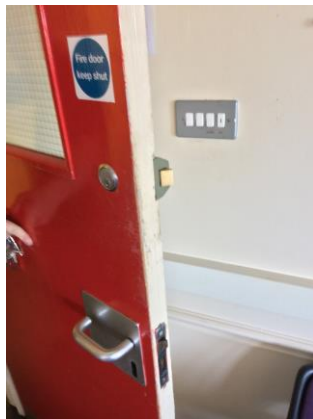
Room D309 is located on an escape stairwell but is not fire rated due to the lack of intumescent strips and smoke seals. The beauty salon does not have fire rated doors; given the increased fire risk in this room it should ideally benefit from its own fire compartment including fire doors. There were also fire compartmentation issues identified in the corridor near room D307, where there are penetrations above the corridor intermediate fire door set.

No intumescent strip or smoke seal to door marked as fire door

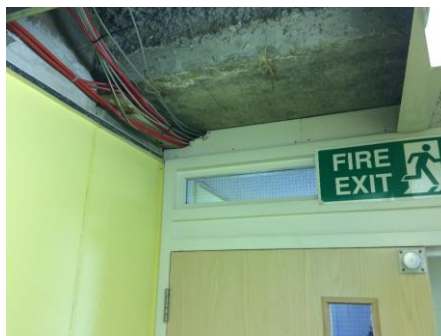
Fire compartmentation breach due to service penetrations

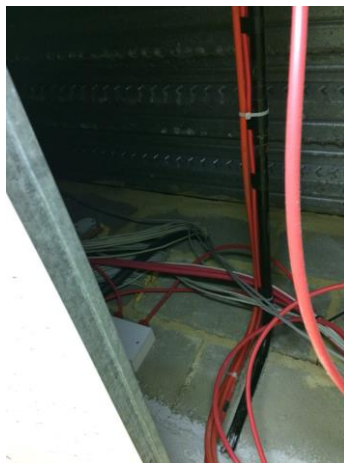
Fire compartmentation breach due to service penetrations

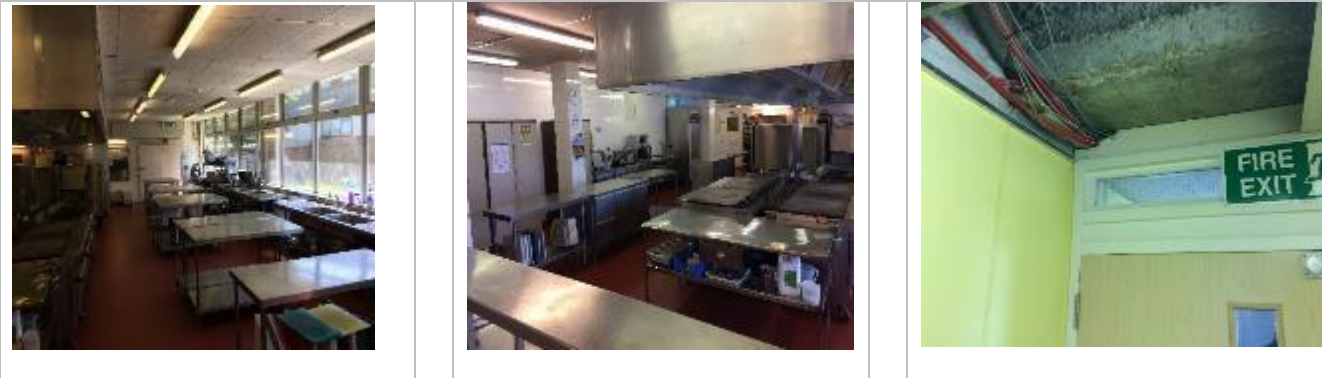
Production kitchen and exposed electrical services requiring attention/making good of compartmentation

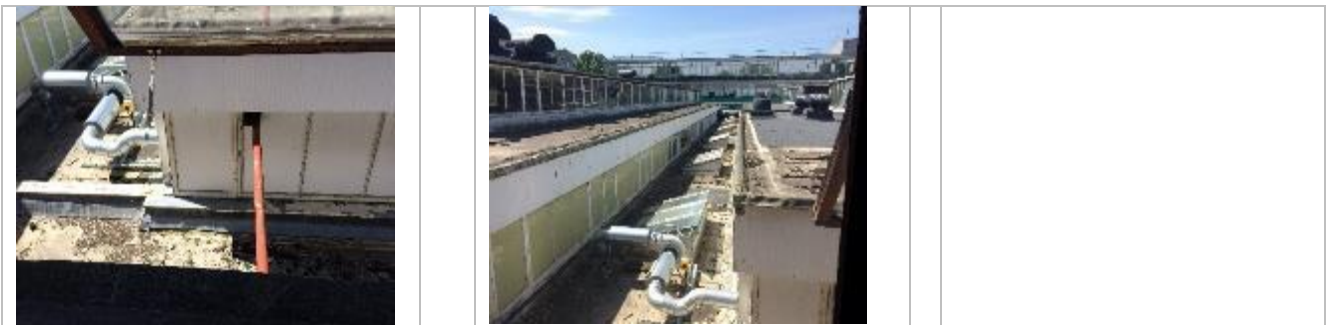
Existing roof mounted extract fans from workshops

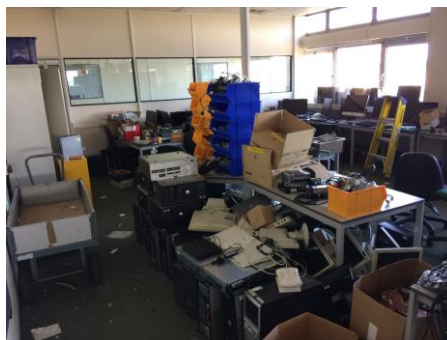
- There are some general housekeeping items in the form of fire doors being wedged open (floor 5. room 56).
- IT store rooms on floor 3 are full of a significant amount of redundant equipment, which would burn readily in the event of a fire.

Fourth floor IT store rooms used to store equipment

As a result of the foregoing, we recommend that a full fire door survey is undertaken to identify all issues so that the College can undertake an overhaul/ corrective actions. A more thorough compartmentation survey is also to be recommended in any high-rise structure (type 3 or 4). Travel distances and means of escape appear to be adequate.

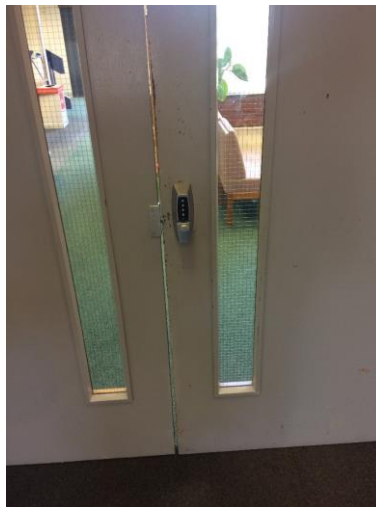
Visible gap between double door set

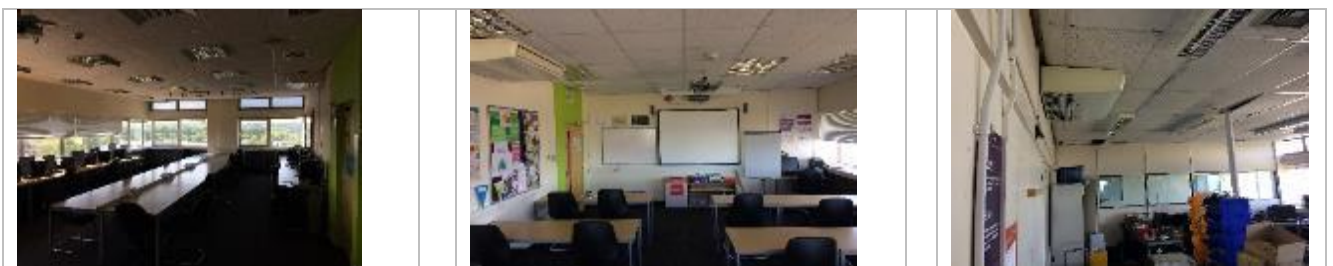
Typical tower classroom dado trunking for small power, split AC unit and perimeter Htg

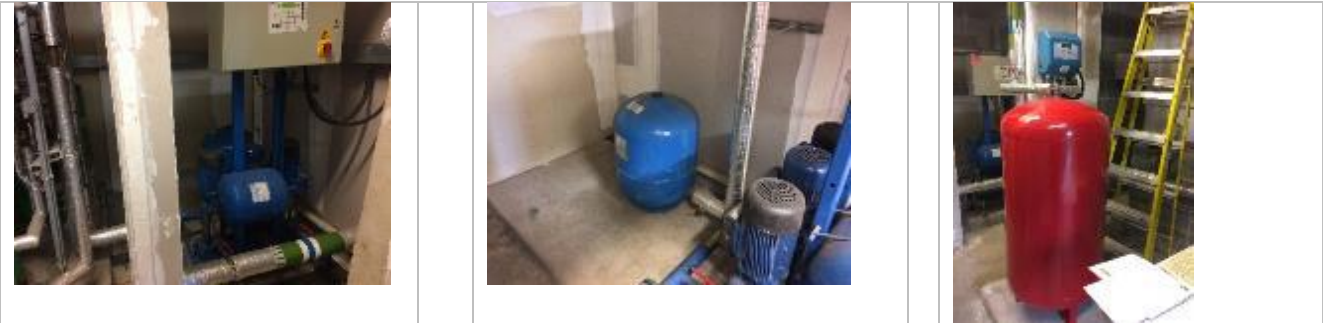
Existing CW Boosters and Expansion Vessels

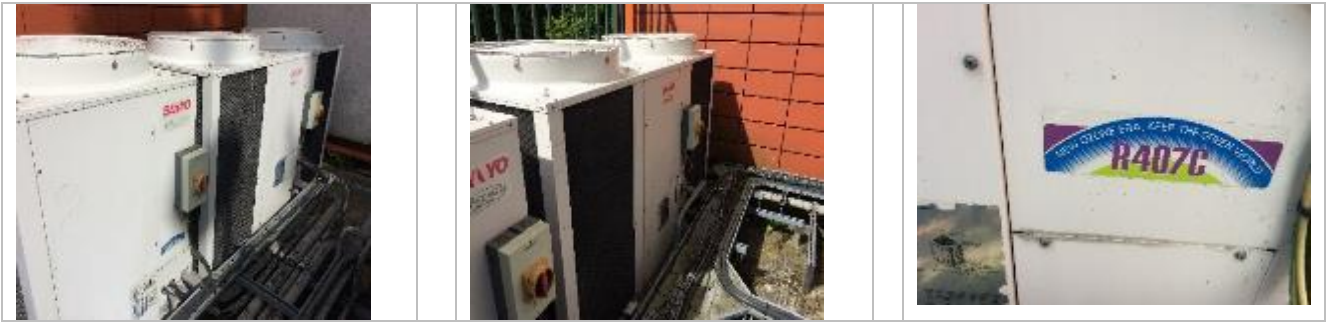
Existing Multi-splits condenser units serving Longley II

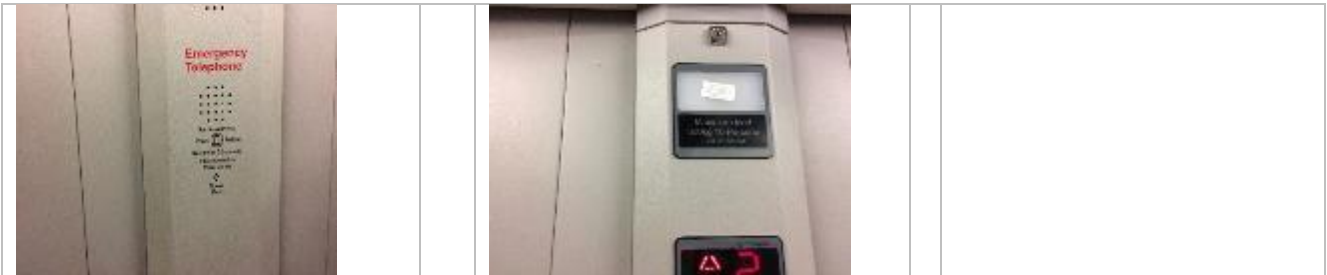
Existing lift in central atrium serving both blocks

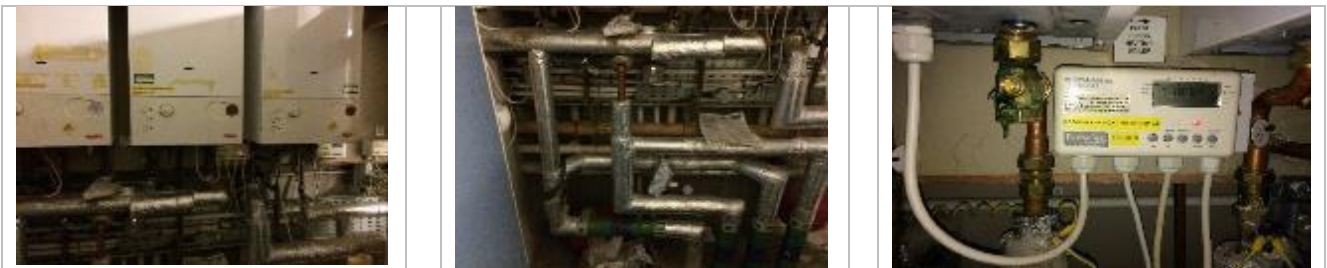
Existing gas fired boiler serving Longley I, Note these are contained within a cupboard. Access is difficult for maintenance and there appears to be no ventilation.

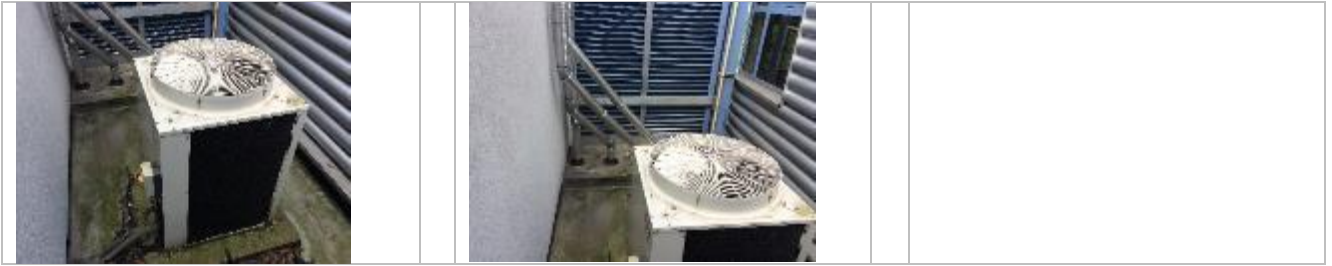
Existing Condenser at mezzanine roof level

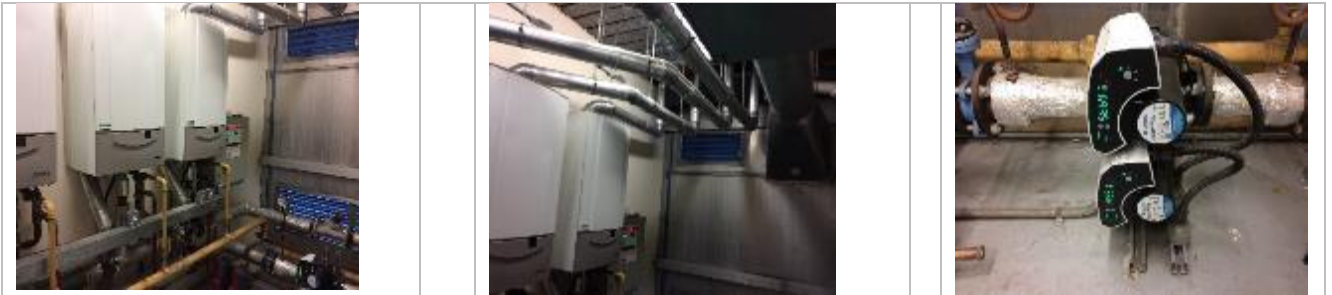
Existing Remeha gas fired boilers, serving Longley II, but located in Longley I & VSD pumps

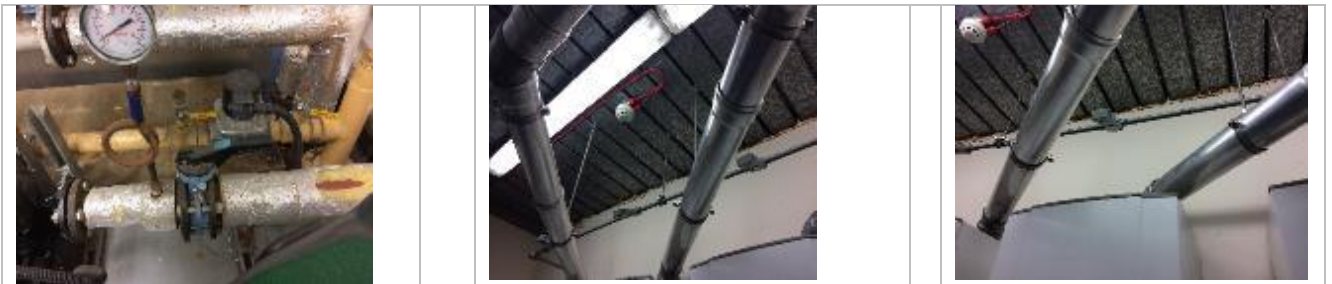
Gas solenoid valve, gas detection and heat/smoke detection

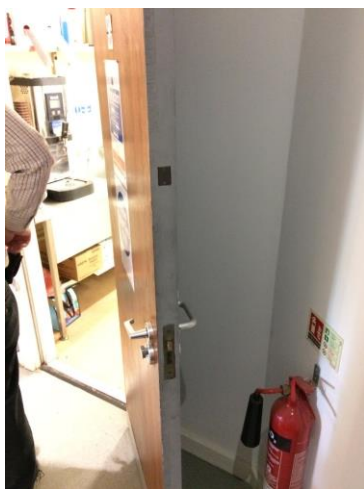
Some general fire safety housekeeping issues were identified, for example there were two fire doors wedged open or not shut on the first floor and the door between Costa and the kitchen was left on the latch – this door also did not have an intumescent strip, the original white doors do not have intumescent strips.

No intumescent strips or smoke seals to the marked fire door between the kitchen and café

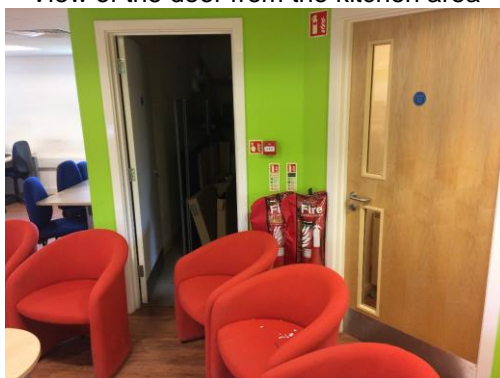
General housekeeping - Escape routes and extinguishers not kept clear, 'keep shut' cupboard left open.

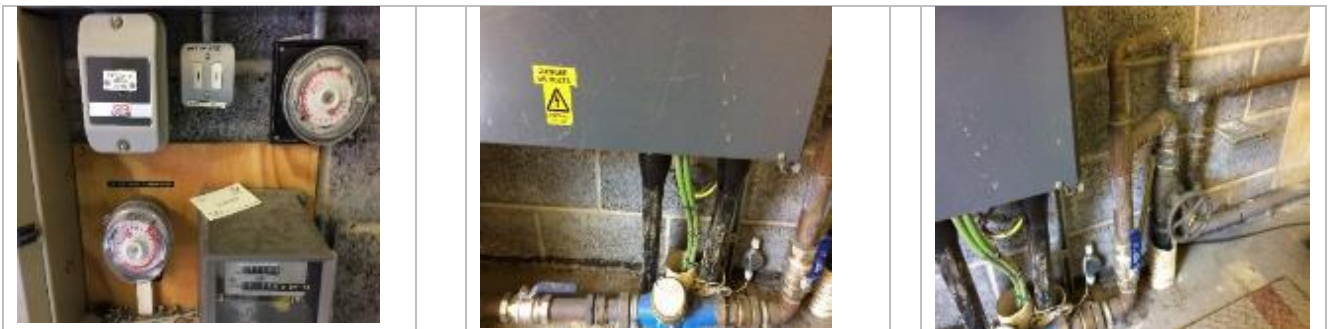
Metering, main electrical incomer and main incoming water main

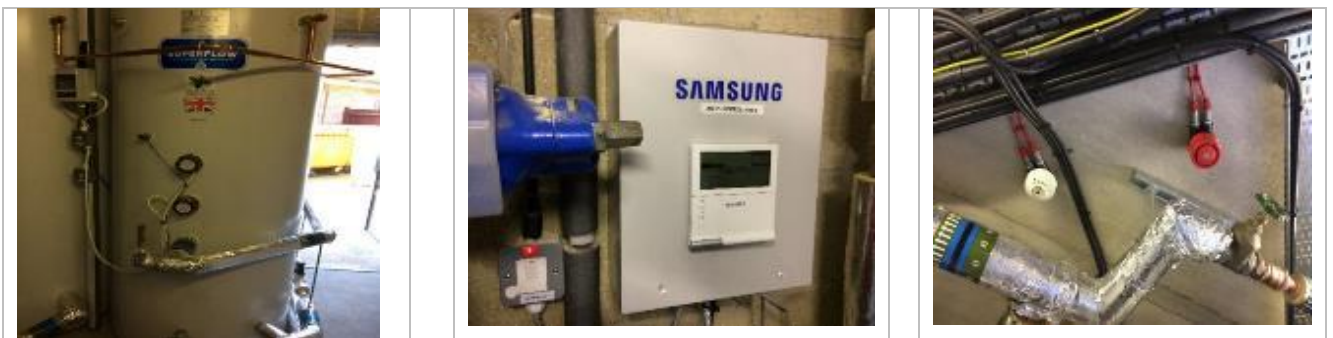
Hot water cylinder, ASHP control and fire detection within plant room

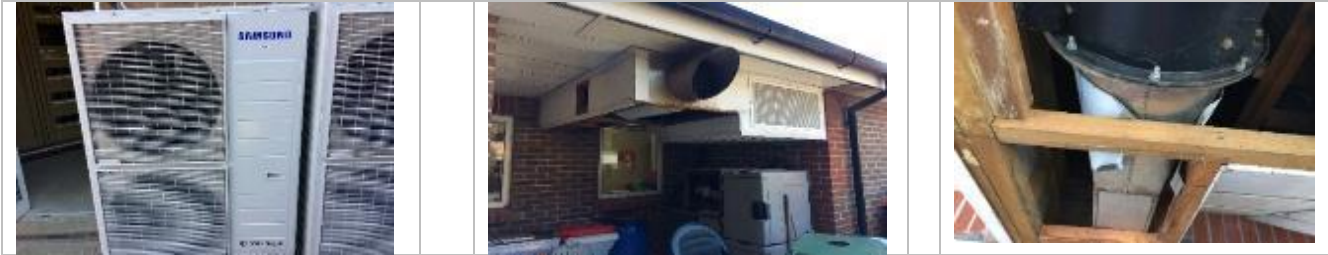
External condensers, kitchen extract and supply unit

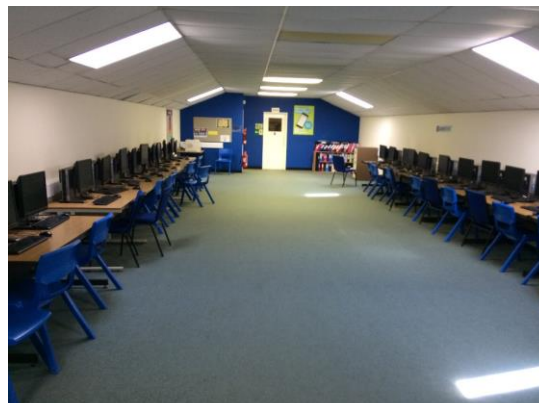
A disabled access lift has been installed to provide access to the first floor, whilst other users can access via two staircases. There is no fire detection within the premises, only a manually operated alarm (call points). The first floor would benefit from smoke detection in particular.

No fire detection within the premises, overview of first floor IT suite

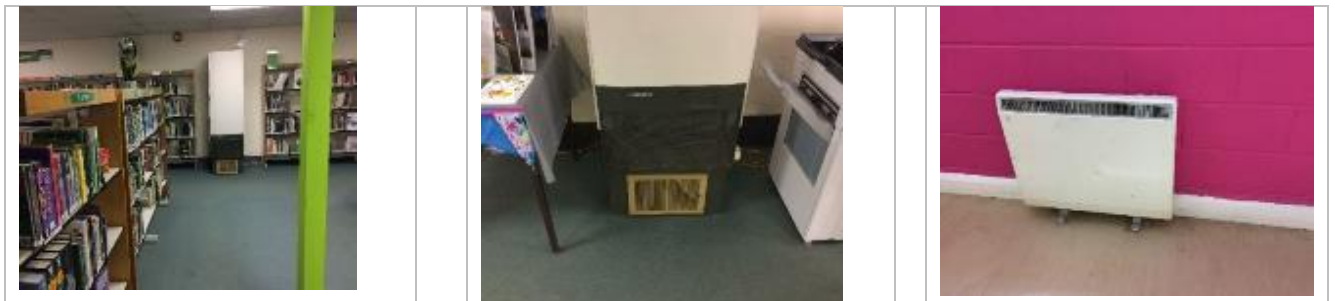
There is no mechanical ventilation to the main space and limited natural ventilation by only the main doors. Heating is provided by a combination of wall electric panel radiators and floor standing warm air blowers, which are not very efficient. There is no AC to the space. The lighting would benefit from being upgrading to bring it in line with current standards.

Electric heating units and panel radiator

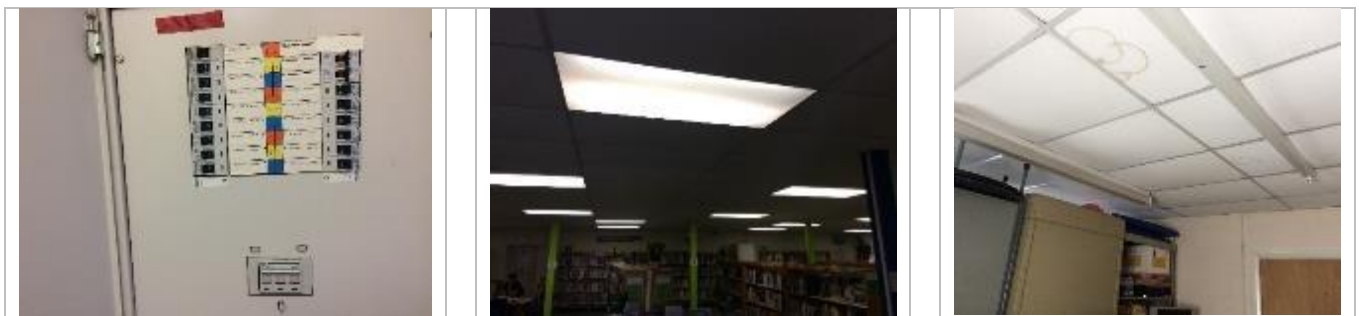
General DB and typical lighting

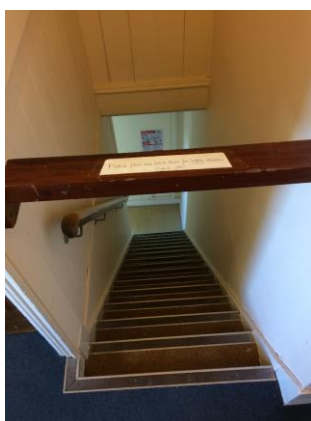
The internal solid doors have been upgraded to fire doors by retrofitting intumescent strips and smoke seals. We have identified that the secondary staircase is steep with shallow treads and a timber safety bar across the top of the stairs, which would require removal prior to escape. The stairs might not, therefore, be suitable as a means of escape and the fire plan should be reviewed to assess.

Secondary staircase which may not be suitable as a means of escape (if designated)

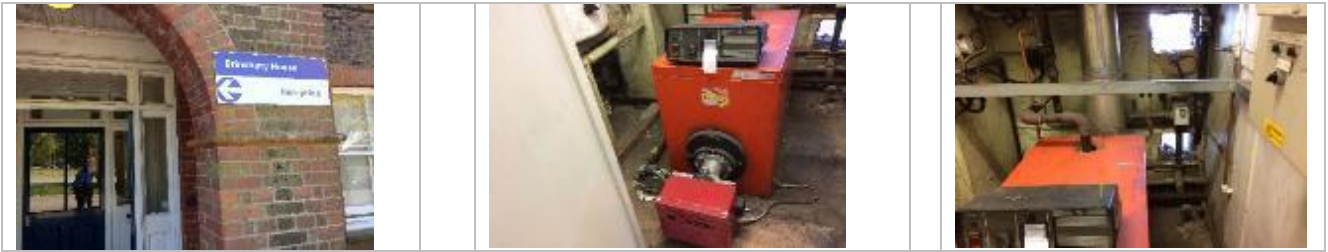
The existing boiler plant is in poor condition (existing age could not be determined), it is an LPG fired boiler, there is no gas detection, fusible links or heat detection. The boiler ventilation is via air bricks at high and low level. These should be checked to ensure that they are compliant. The existing controller is a Honeywell Aquatrol 2000 compensator with night set back.

Existing Htg boilers

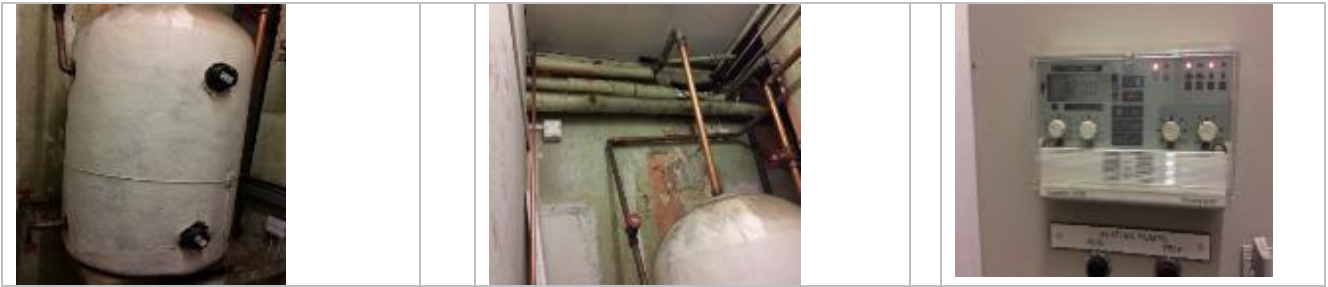
The domestic HWS needs modernising, it also contains a mixture of galvanised and copper pipework. There appears to be a secondary return, although we could not locate a pump on the return.

Existing HW cylinder and Htg controls

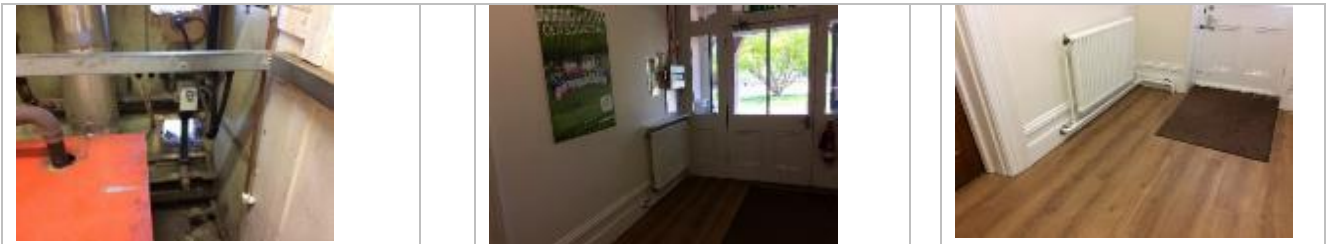
The heating is LTHW serving a mixture of cast iron and steel radiators, via a single pipe distribution system.

Existing port valve arrangement & radiators

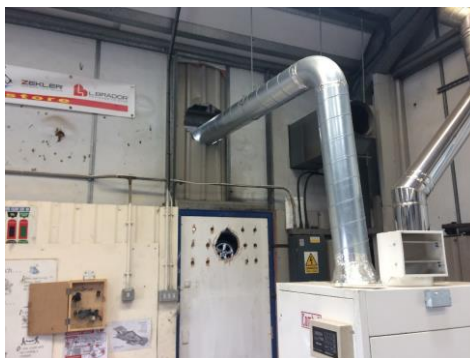
The workshops are not separated by compartments due to the nature of construction and given the usage, materials and consumables present, the fire risk is considered to be high. Due to the foregoing, we would recommend a full fire risk assessment to identify required actions.

No compartmentation between workshops

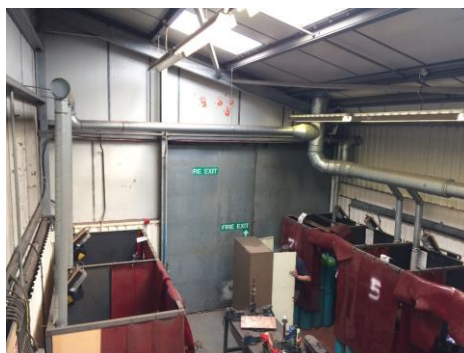
Welding workshop with locked fire exit

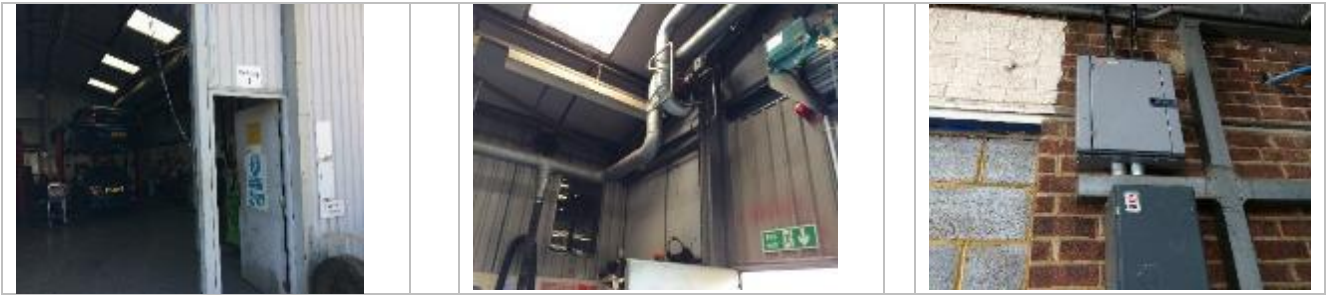
Existing exhaust extract system and DB.

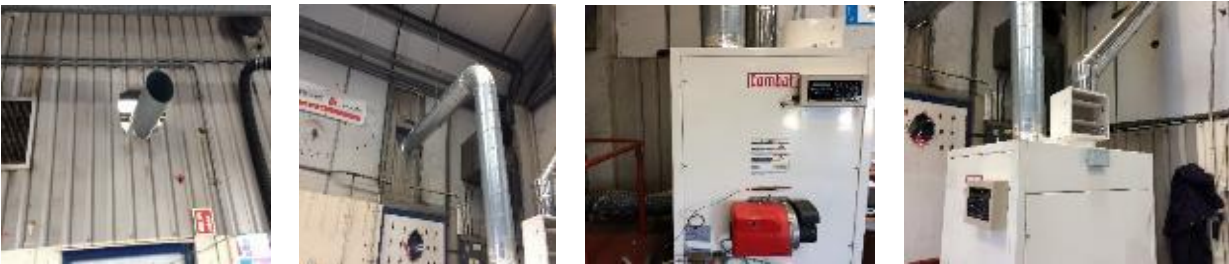
Warm air duct providing heating to workshop, oil-fired warm air heater.

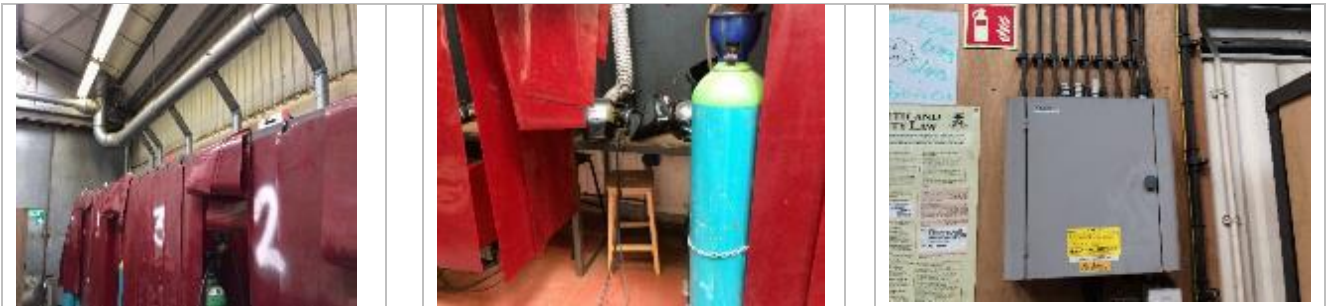
Welding booth extract system & electrical DB

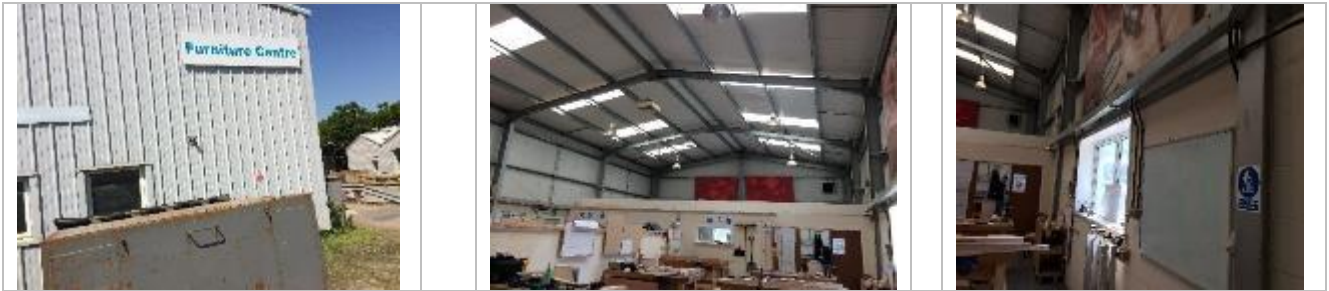
High level lighting, fire detection and electrical containment

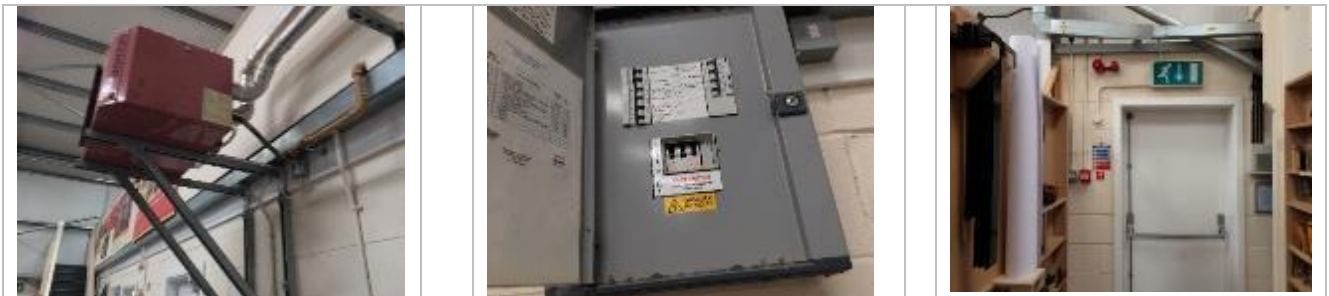
Direct gas fired unit heater, DB and emergency escape route

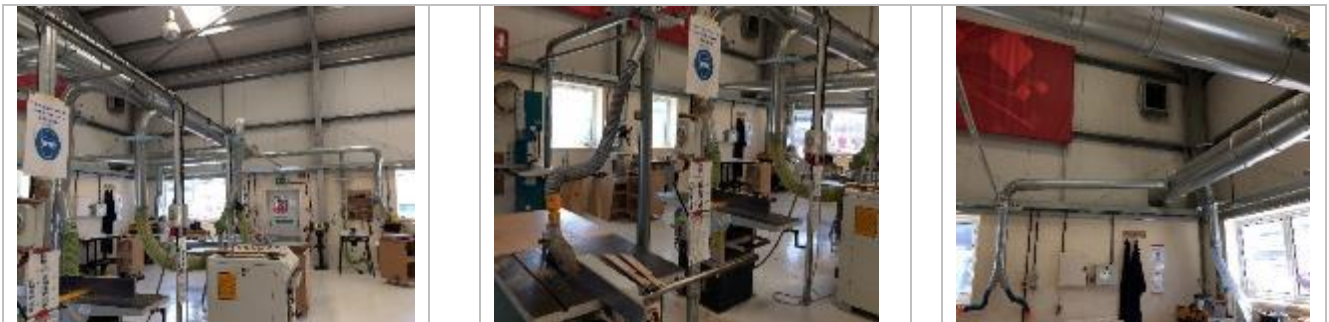
Extract system to equipment & ducting at high level with supply grille at high level

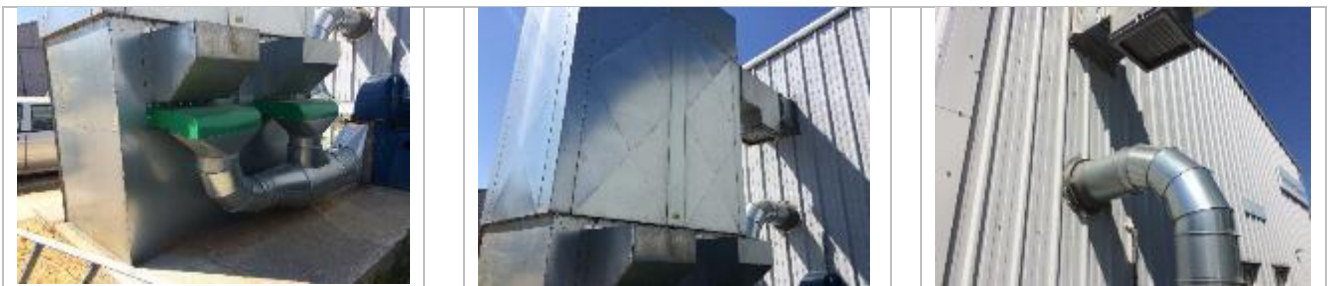
External recycling filter and fan combination unit.

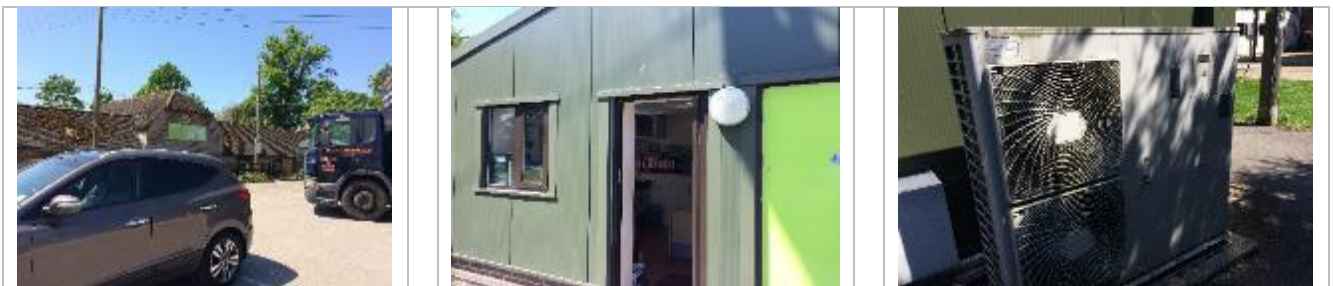
Office and air source heat pump unit

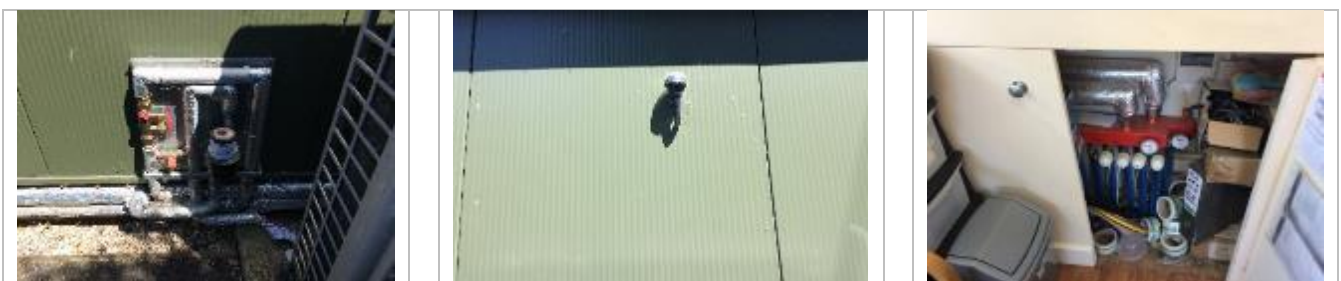
Air sourced heat pump manifold, underfloor heating manifold

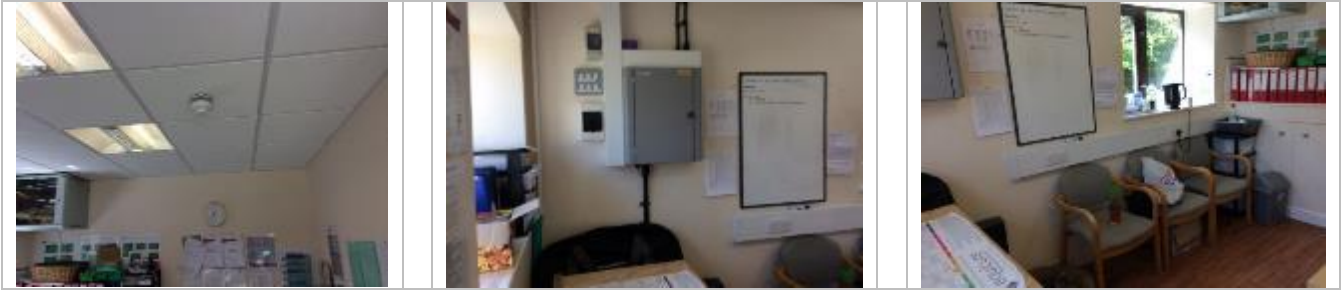
Typical lighting and detector, DB and dado trunking

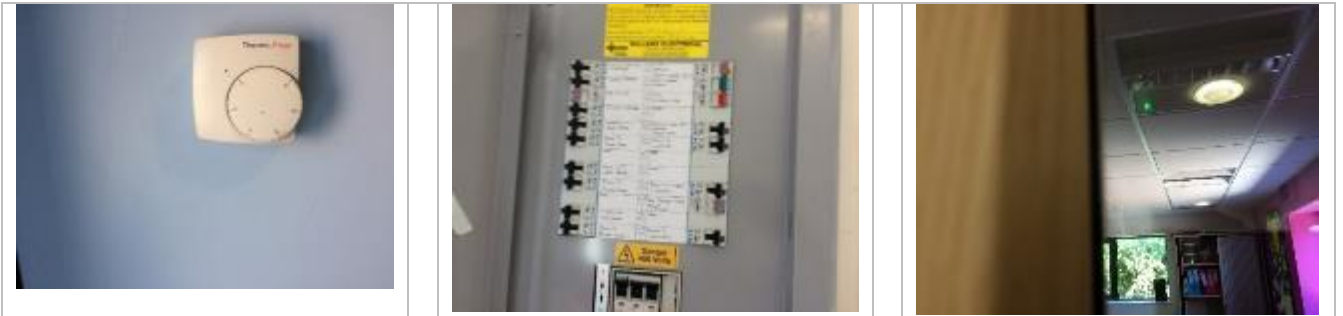
Underfloor heating room sensor, DB and classroom emergency light fitting

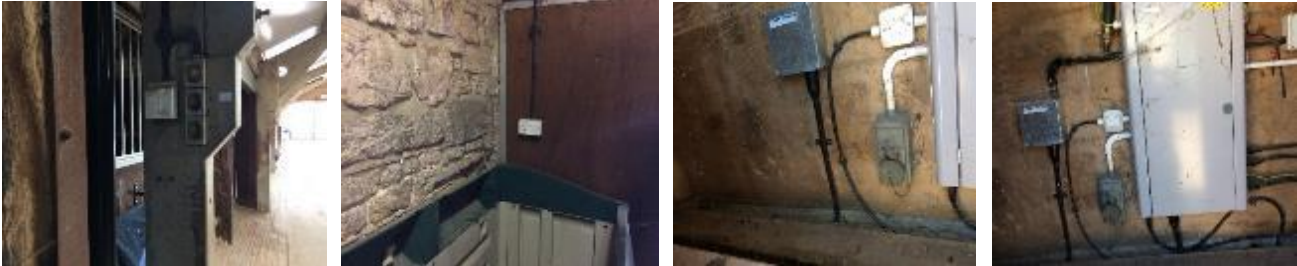
Lighting is provided via florescent tubes and small power is provided via a central DB with socket at some locations although these are not IP rated. Light switch appear to be shower proof.

Existing light switches, sockets, and main DB

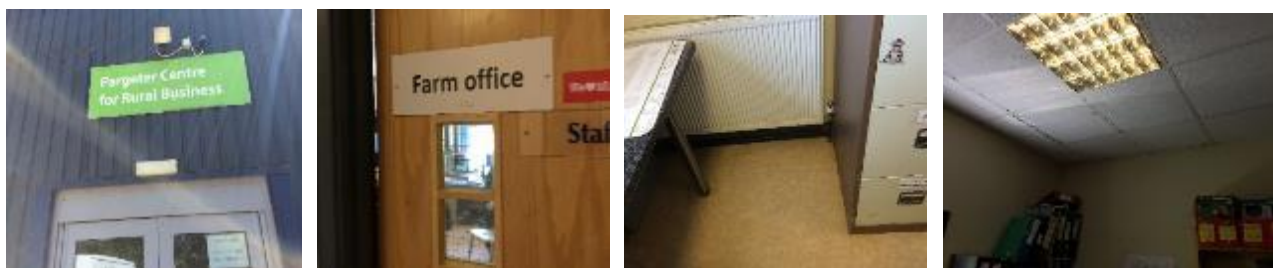
Heating is provided by LTHW heating distribution serving radiators via a wall mounted Boiler (which we could not access at the time), local TRV’s are fitted to each radiator for additional internal space temperature control.

Typical office Htg and lighting.

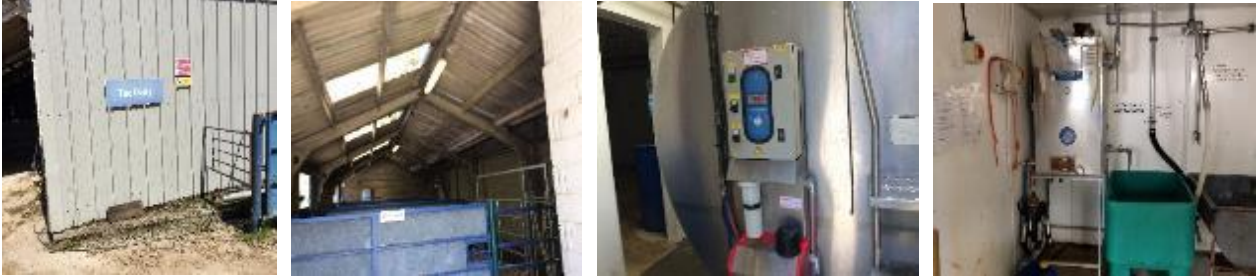
Dairy pasteurisation vessel and storage

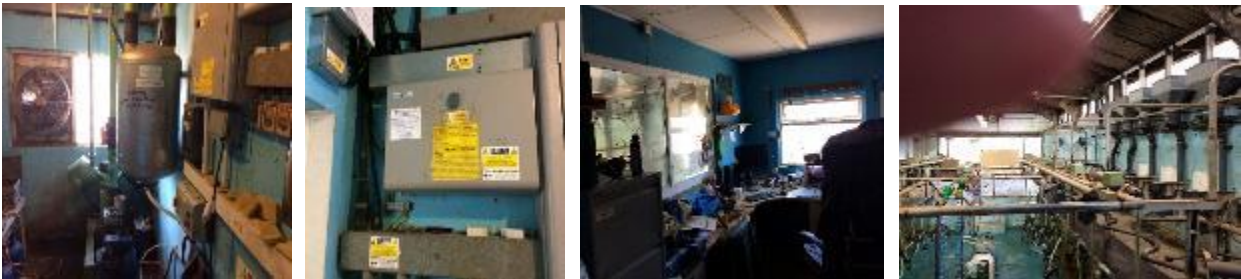
The dairy differs to the cattle sheds as there is more frequent human usage of the building, however, the facility has no fire detection or alarm within the dairy building and consideration should be given to installing

General electrical DB, office and milking parlour

a suitable system that is also linked to the main FA panel. There is no mechanical ventilation and heating is local electric blower and radiant lamps.
