STOCK CONDITION SURVEYS OF BUILDINGS AT CHICHESTER, BRINSBURY AND CRAWLEY

June 2018

Chichester College

Ridge and Partners LLP

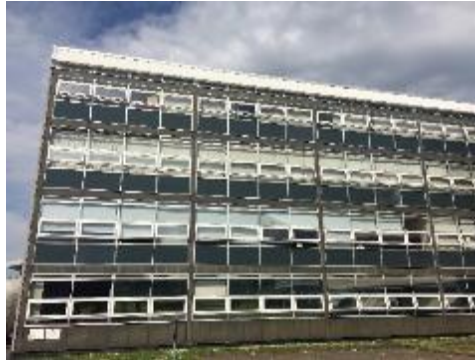
No significant structural defects were noted. No access to the flat roof was available (thus its condition cannot be assessed).

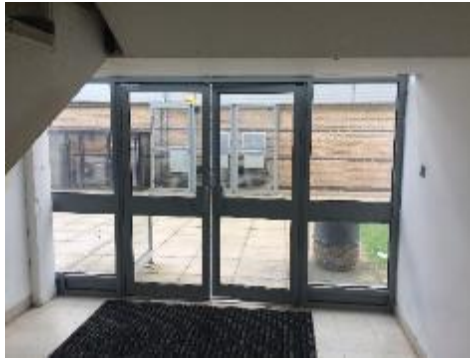
No significant defects were noted in respect of internal walls or the compartmentation that they provide, although it should be noted that we only undertook a visual survey from floor level and cannot comment upon concealed areas (e.g. breaches in compartmentation above ceilings, and where junctions are concealed by finished such as skirtings etc.).

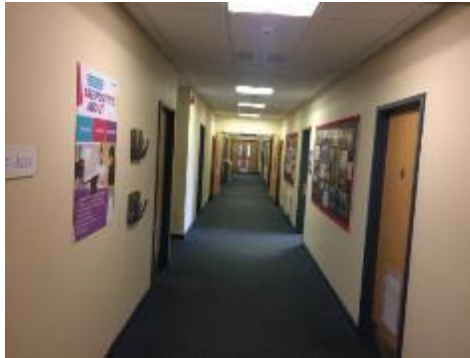
Internal doors are generally, in old but serviceable condition, some require easing and adjustment, especially to ensure correct operation of closer devices.

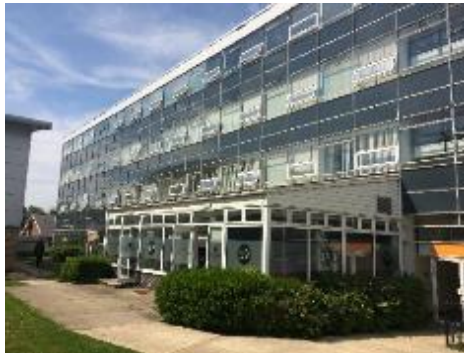
No significant structural defects were noted. No access to the flat roof was available (thus its condition cannot be assessed).

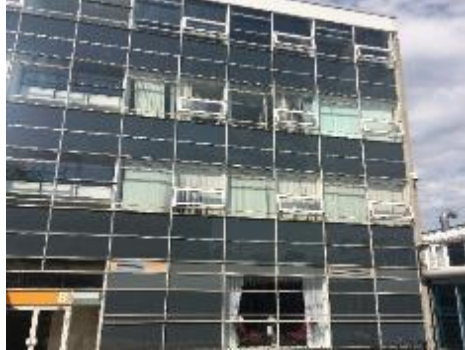
Metal frame external doors are present. Aluminium windows with infill panels are old and in moderate condition (we recommend that the panel material is investigated for limitation of fire spread) and should be considered for renewal on thermal efficiency grounds.

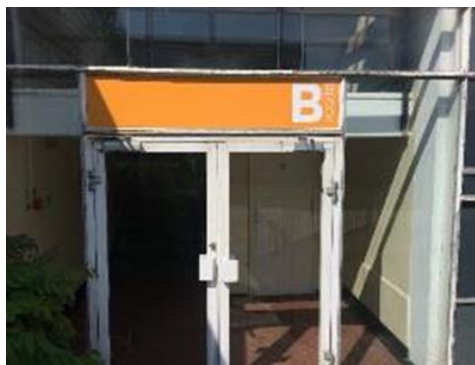
No significant defects were noted in respect of internal walls or the compartmentation that they provide, although it should be noted that we only undertook a visual survey from floor level and cannot comment upon concealed areas (e.g. breaches in compartmentation above ceilings, and where junctions are concealed by finished such as skirtings etc.).

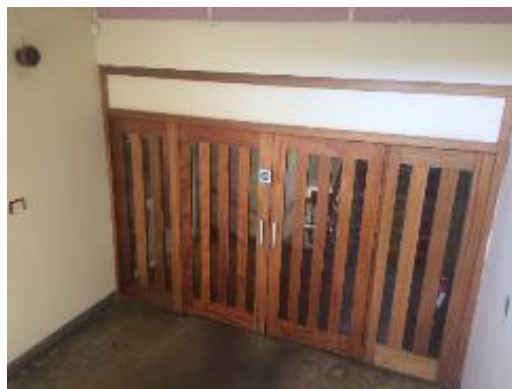
Internal doors are generally, in old but serviceable condition, some require easing and adjustment, especially to ensure correct operation of closer devices.

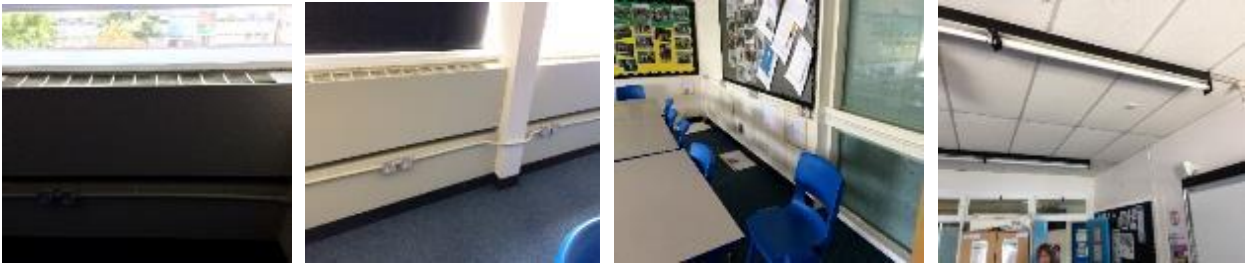
The heating for this block is served from boiler plant located in Block A. Heating to the classroom is via wall hung LTHW perimeter convectors which are in fair condition, but some require some attention.

General Perimeter convectors, Typical small power distribution & lighting to classrooms

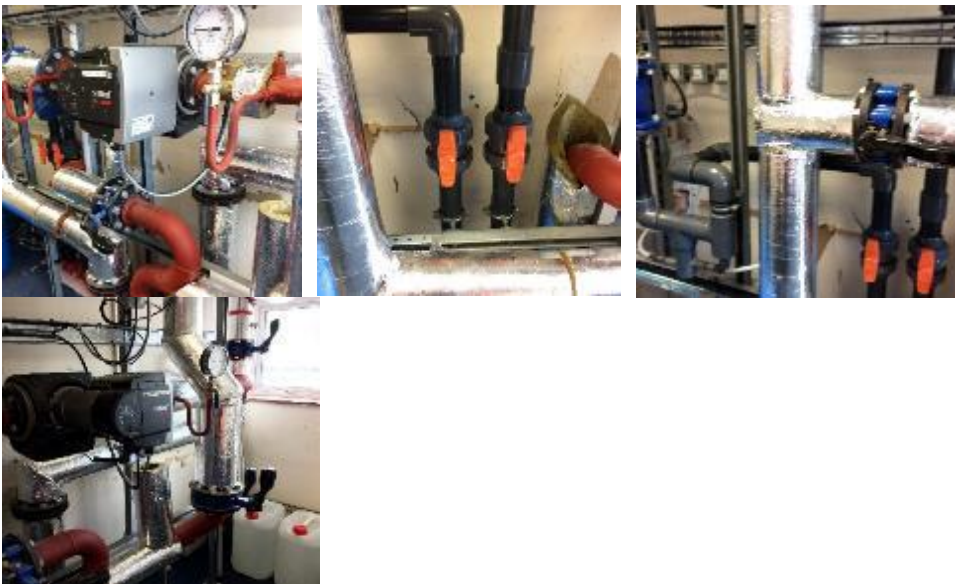
General Piping & Pump layout for the HWS distribution within the plantroom

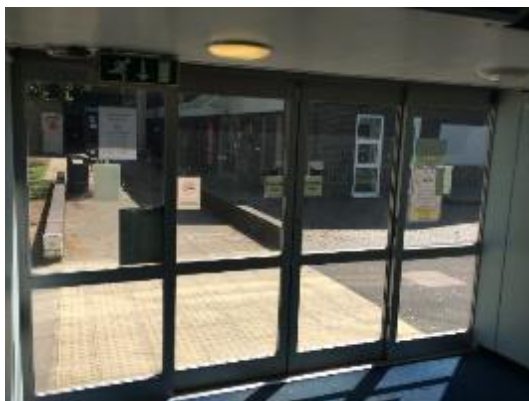
No significant defects were noted in respect of internal walls or the compartmentation that they provide, although it should be noted that we only undertook a visual survey from floor level and cannot comment upon concealed areas (e.g. breaches in compartmentation above ceilings, and where junctions are concealed by finished such as skirtings etc.).

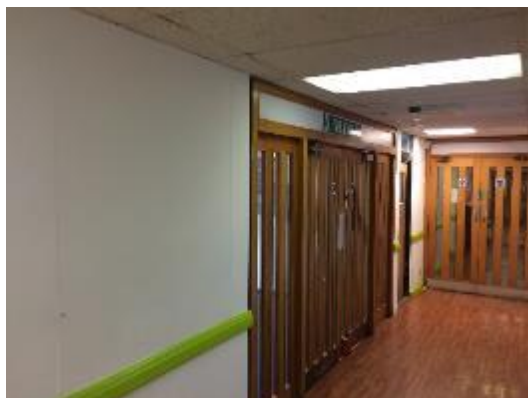
Internal doors are generally, in serviceable condition, some require easing and adjustment, especially to ensure correct operation of closer devices.

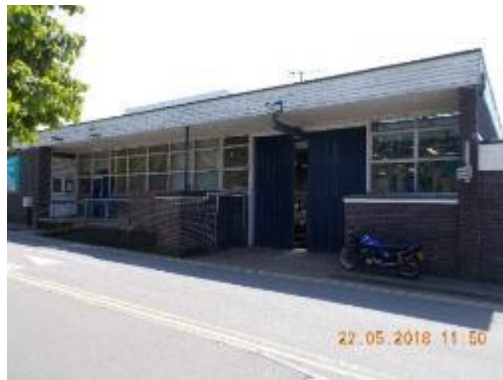
No major structural defects were noted. The roof appears to be a flat felt decked roof, drip edges were noted to be of good condition, but the main coverings were not accessible and have been estimated. There are no stairs present.

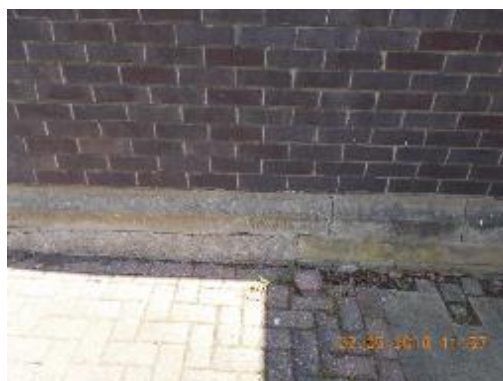
All windows and external doors were noted to be in a good/reasonable state of repair. No significant issues noted with internal walls and partitions.

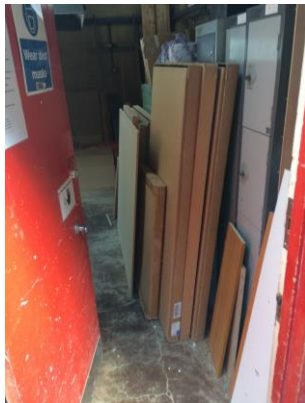
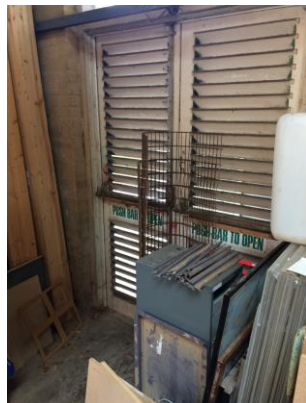
- W70 – There are no fire call points to activate the alarm within the room. The fire escape exit is blocked with materials and is located next to heavy machinery.
- W71 – No manual call points to activate the fire alarm. The mezzanine store room should only be used as a store room due to the lack of fire detection and only one means of escape.
- W72 – No call points within the car mechanic workshop
- W73 – A mezzanine office is present and due to the lack of fire detection and only one means of escape, should only be utilised as a store room.
- W81 – No call points within the car mechanic workshop and the mezzanine office should only be used as a store room due to lack of fire detection and only one means of escape. In addition, the internal classroom only has one point of entry/ exit, is not a fire compartment, and combustibles are stored directly next to the door.

Obstructed escape routes leading to partially blocked final exit doors

Due to the foregoing, we would recommend that a full fire risk assessment of the building is carried out, as a matter of urgency, which will produce a list of required corrective actions.

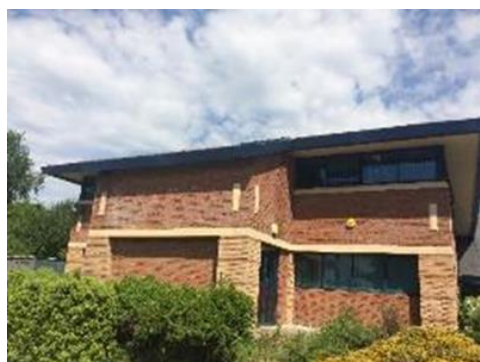
Windows, external doors, internal walls and partitions are noted to be modern and appear satisfactory.

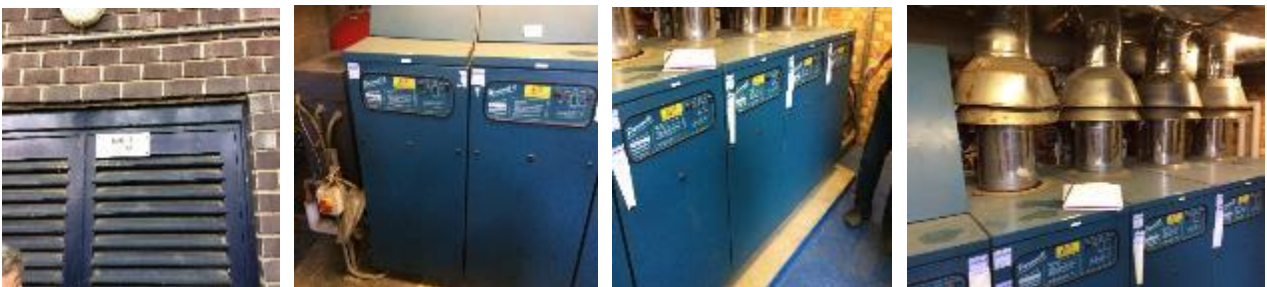
The existing heating to the building is served via 6 Nr Hamworthy Purewell gas fired boilers, 4 of which are atmospheric gas fired and 2 are forced draft gas fired. All connect to the same flue dilution system. They are in a fair condition.

Existing Gas fired boilers & Flues

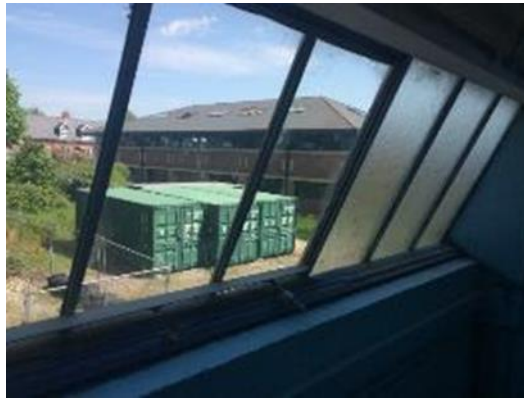
Windows noted to be in poor condition, renewal required. Internal walls, doors and partitions are all noted to be in reasonable condition, although with some breeches in compartmentation.

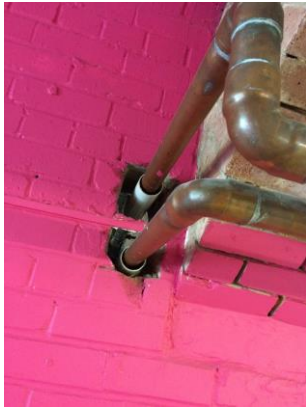
The ground floor union room has several service penetrations through solid walls, which are not fire stopped. Mechanical ventilation is not provided and the structure is heated by old fashioned gas fired hot air blowers.

Service penetrations through common room solid walls

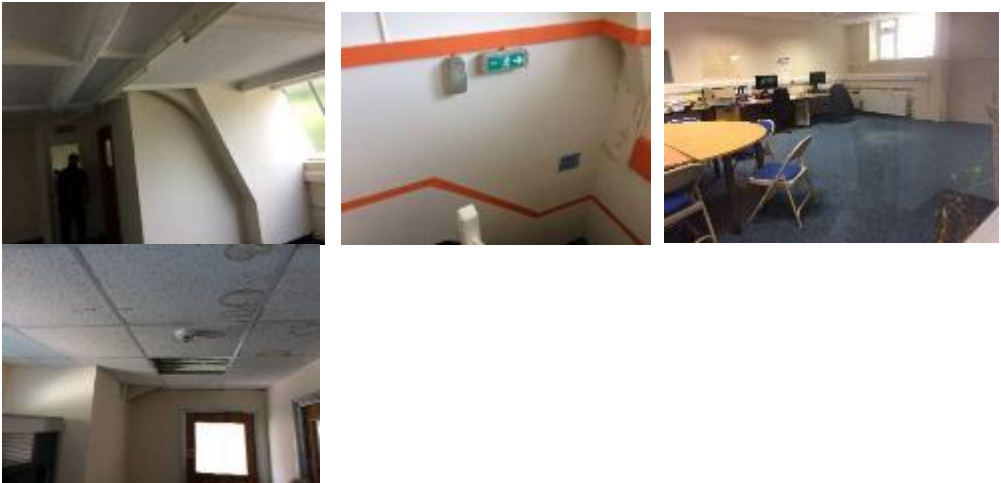
Typical lighting, small power and FA detection

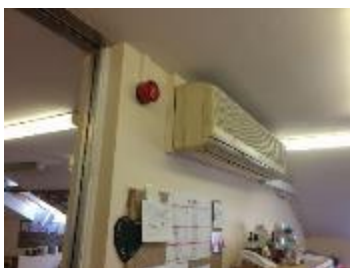
Comfort cooling wall hung split unit

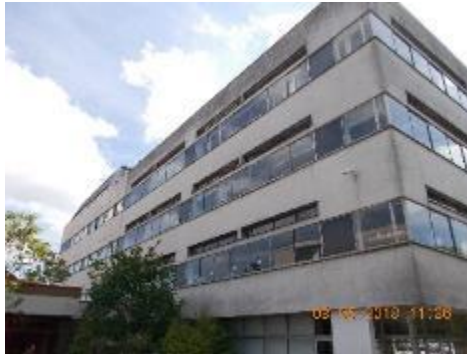
No significant structural defects were noted. No access to the flat roof was available (thus its condition cannot be assessed).

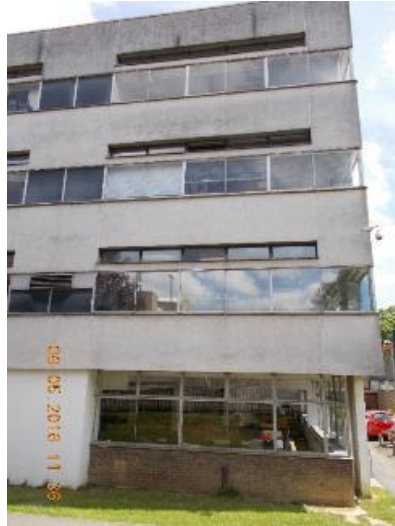
Windows and external doors in moderate condition with a few ad-hoc repairs required. The older windows should be considered for renewal to double glazed.

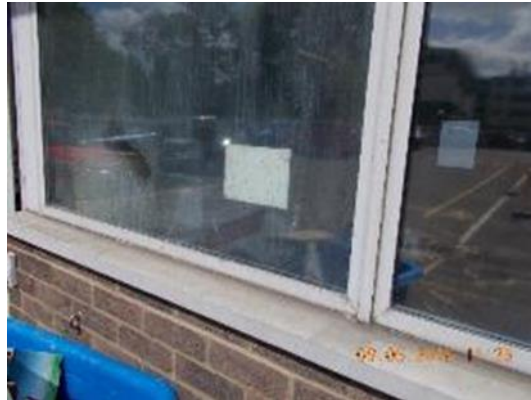
Some compartmentation breeches were noted. It should be noted that we only undertook a visual survey from floor level and cannot comment upon concealed areas (e.g. breeches in compartmentation above ceilings, and where junctions are concealed by finished such as skirtings etc.).

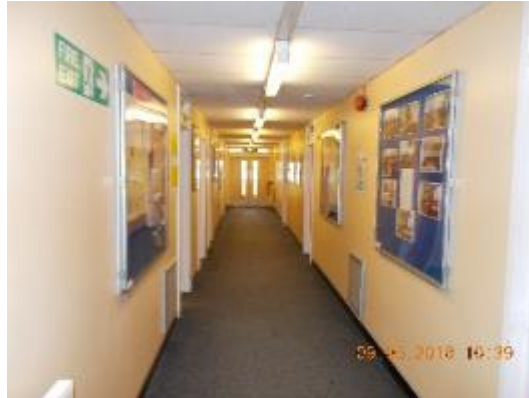
Internal doors are generally, in old but serviceable condition, some require easing and adjustment, especially to ensure correct operation of closer devices.

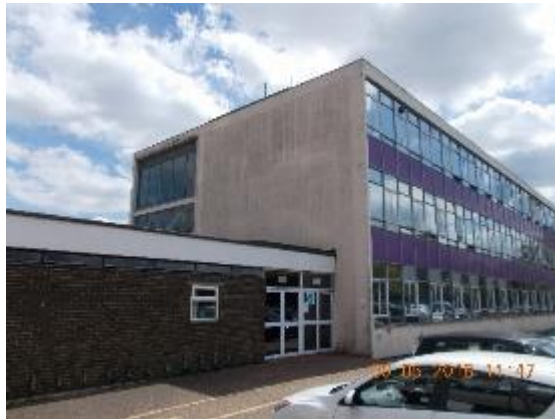
No significant structural defects were noted. No access to the flat roof was available (thus its condition cannot be fully assessed), the roof image has been taken from The Tower and from a distance indicates an older and worn finish.

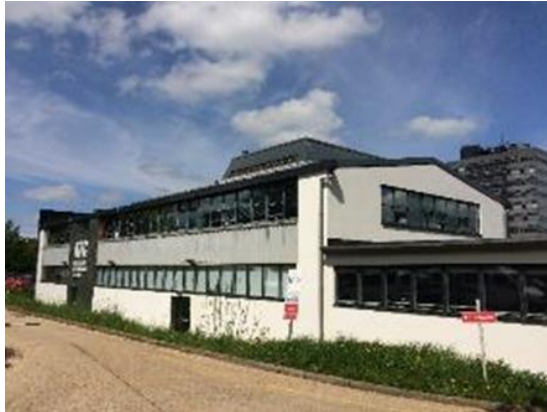
No significant structural defects were noted. Flat roof with felt and skylight details, in moderate to poor condition.

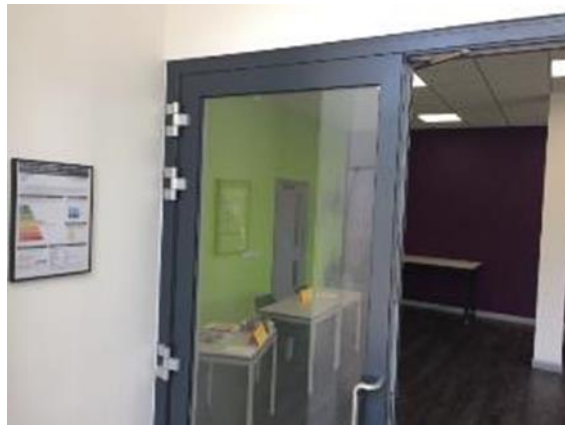
Internal partitions to new IT suite crudely installed over electrical sockets and creates a room within room, needs urgent attention.

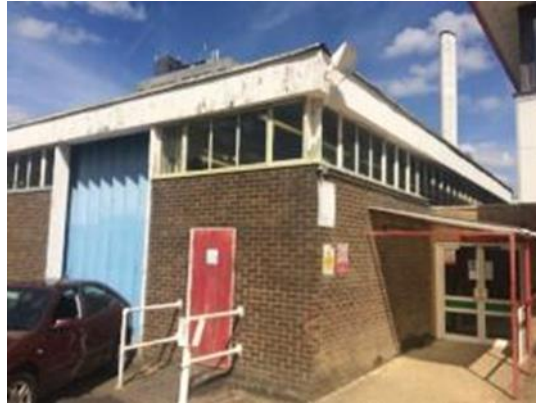
No significant structural defects were noted. The flat roof noted to be in poor condition and very dated.

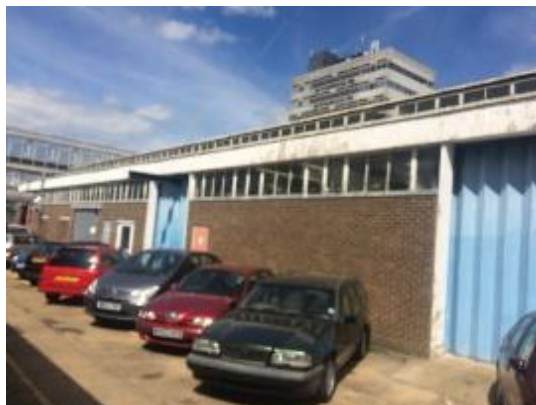
Windows and external doors are in poor condition.

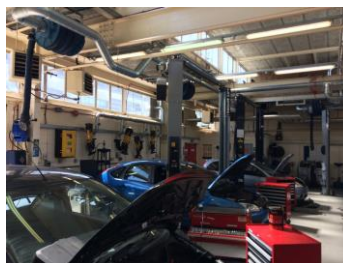
The premises are believed to date from circa 1950s and have poor sound resistance and power conservation due to the roof structure, single glazing and workshop roller shutters. There are internal dead end offices with some rooms (W017 & W018) that have no fire detection within. Furthermore, most of the rooms do not benefit from fire door sets or detection and there are plenty of fuel sources in the form of timber in the joinery workshops and consumables in the car workshops. Due to the foregoing, we would recommend a full fire risk assessment to identify required actions.

No fire detection

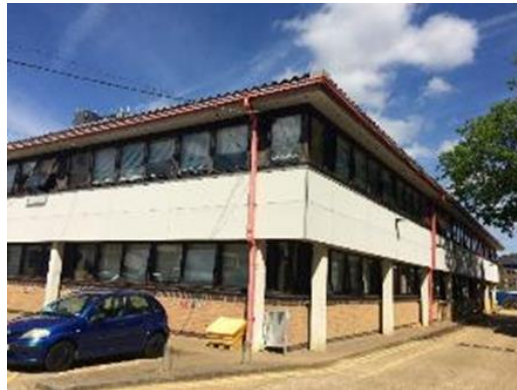
No significant structural defects were noted. No access was available to the shallow pitched roof (thus its condition cannot be fully assessed), the age of the building would infer that the roof is within its design life.

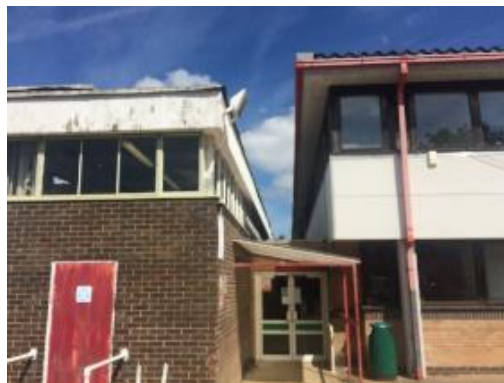
External walls are a mixture of pointed brickwork and cladding panels. Moderate condition to all present.

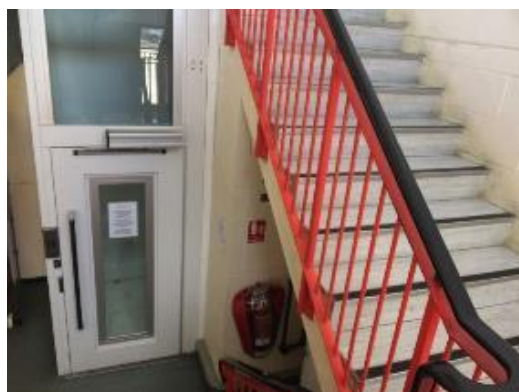
Stairs found to be in fair condition.

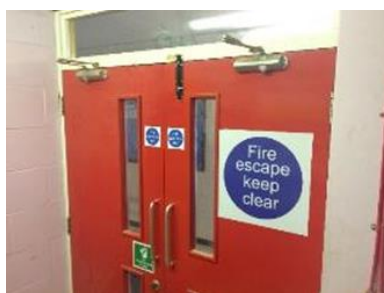
Internal doors are generally, in serviceable condition, some require easing and adjustment, especially to ensure correct operation of closer devices.

No significant defects were noted in respect of internal walls or the compartmentation that they provide, although it should be noted that we only undertook a visual survey from floor level and cannot comment upon concealed areas (e.g. breaches in compartmentation above ceilings, and where junctions are concealed by finished such as skirtings etc.).

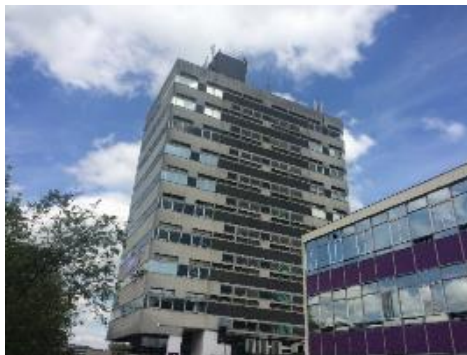
The top two floors of The Tower have undergone a refurbishment whereas the remaining floors are dated. The concrete framed high-rise structure is showing no immediate signs of significant defect, although the windows are original single glazed units, which will require renewal in the next few years. The Tower is a high-rise structure and therefore subject to more stringent controls.

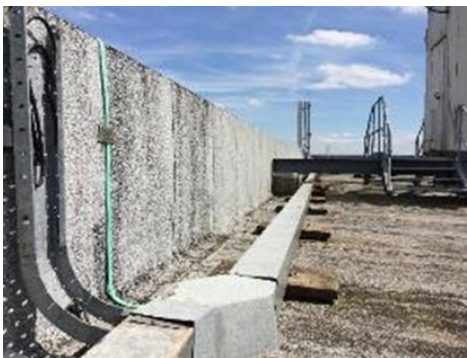
No significant structural defects were noted, although a specialist structural engineer's report on this construction form is recommended (including concrete testing). The felt roof (possible overlay system) found to be generally in good condition. Lightning protection has oxidized somewhat and is weathered (specialist cyclical checking is required to determine its performance), large amount of M&E noted. Issue with nesting seagulls.

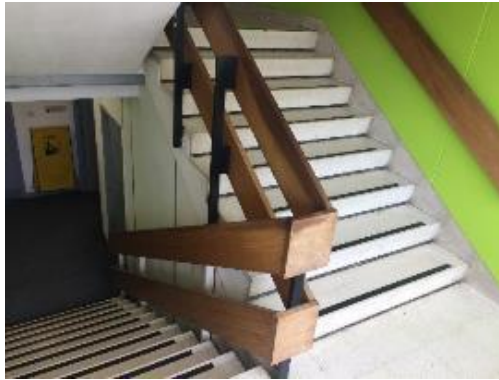
Stairs appear in a good/reasonable state of repair with some normal wear and tear evident. Note that the balustrades on this stair are greater than 100mm in places and consequently do not meet current Building Regulation standards.

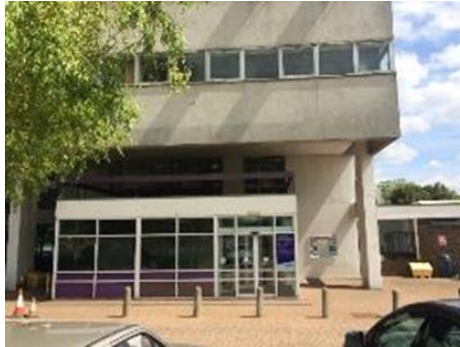
External Walls are precast concrete panel construction with some pointed brickwork. All in moderate condition we advise that the cladding is closely monitored for future repairs, including abseil checks that look for loose areas.

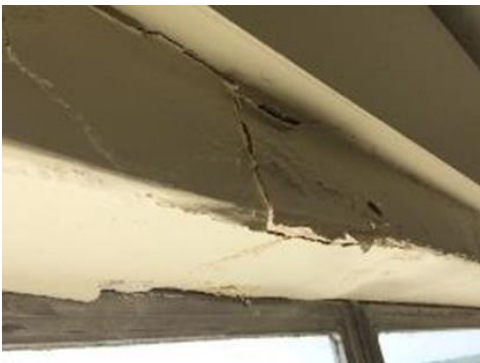
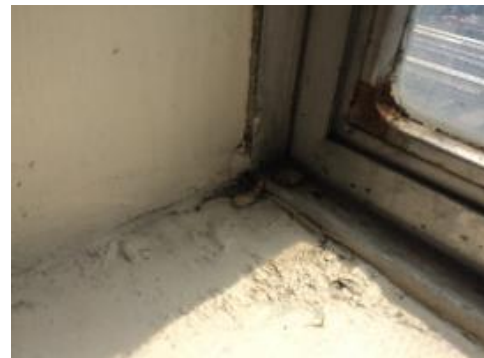
The windows are original single glazed units that require renewal, note water ingress to window reveals and window heads in both stairwells. These areas require urgent attention and a structural appraisal of the frame to check for deterioration as a consequence of the water ingress (corroded reinforcement, carbonation etc.).

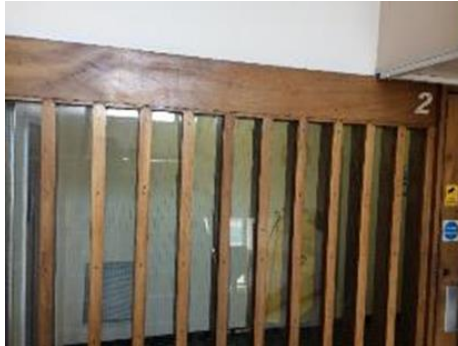
There are a mix of modern and dated internal doors, they are generally in serviceable condition, some require easing and adjustment, especially to ensure correct operation of closer devices.

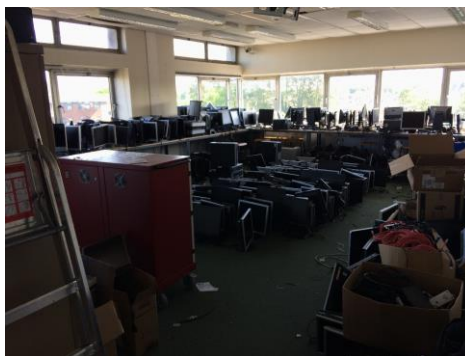
- There are some general housekeeping items in the form of fire doors being wedged open (floor 5. room 56).
- IT store rooms on floor 3 are full of a significant amount of redundant equipment, which would burn readily in the event of a fire.

Fourth floor IT store rooms used to store equipment

As a result of the foregoing, we recommend that a full fire door survey is undertaken to identify all issues so that the College can undertake an overhaul/ corrective actions. A more thorough compartmentation survey is also to be recommended in any high-rise structure (type 3 or 4). Travel distances and means of escape appear to be adequate.

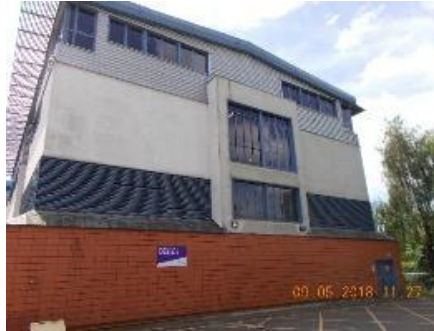
No significant structural defects were noted. The roof coverings are standing seam sheet metal, modern and in good condition.

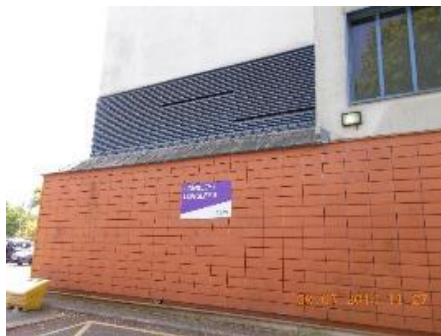
Windows and external doors found to be in satisfactory condition.

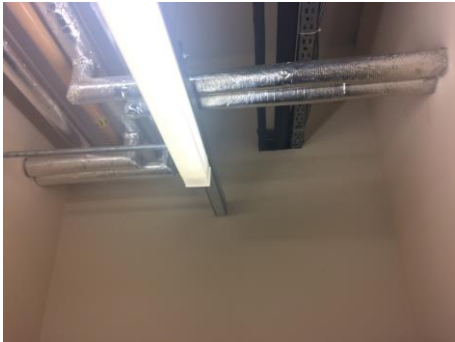
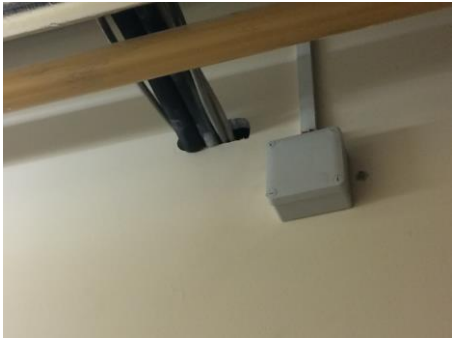
Longley I is a 2 storey 2006 construction and therefore will have been designed to comply with modern regulations. We did, however, identify some breaches to the fire compartmentation between the two buildings above the dividing corridor fire door set, as well as throughout the second floor corridor walls. As the rooms off the corridor appear to have been designed as separate compartments, we would advise that they require fire stopping to maintain compartmentation. There were further penetrations identified on the first floor through the workshop compartment.

Compartmentation breaches

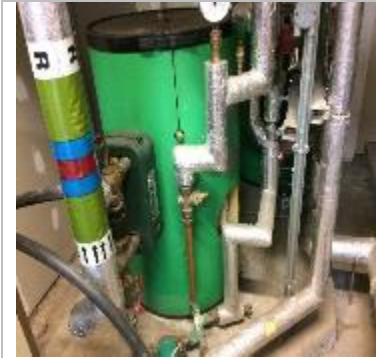
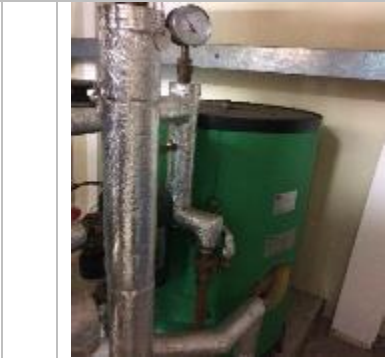
Existing water treatment plant

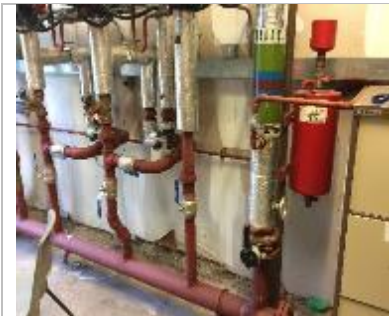
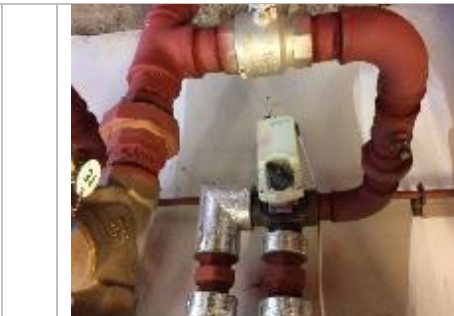
Existing LTHW header & 3 port valve

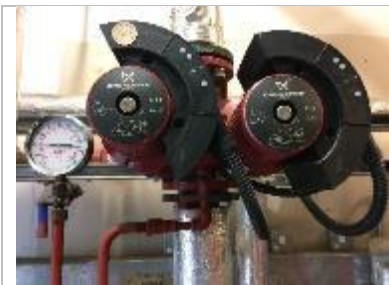
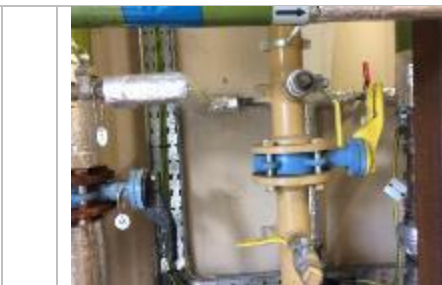
Existing VSD Htg Pumps & Gas manual shut off valve

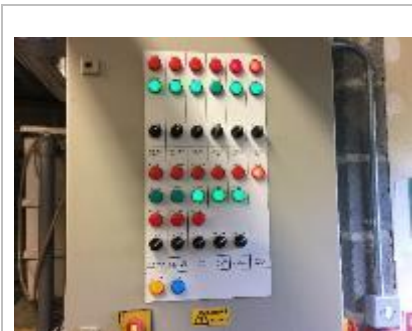
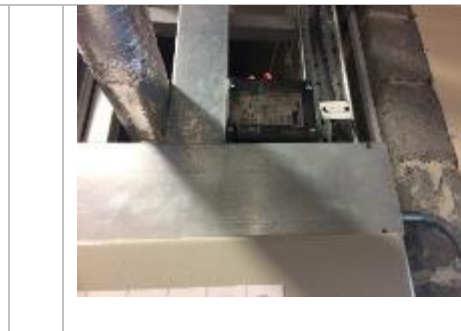
Existing MCCP and Meter

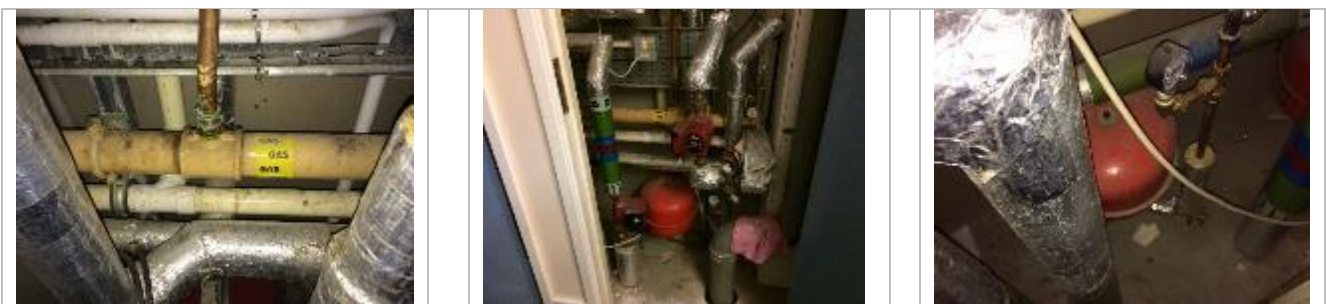
Existing gas feeding boilers, existing joint appears to be a compression fitting used, this is non-compliant under current regulations. This should be rectified as soon as possible.

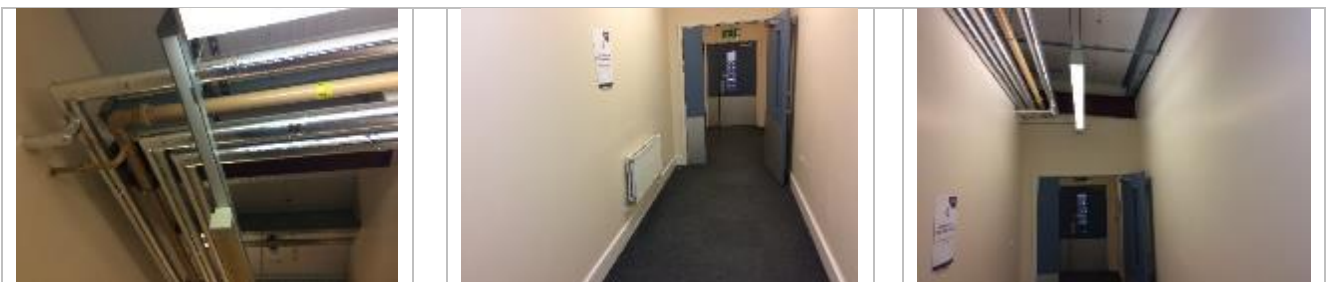
General services distribution at high level within corridor

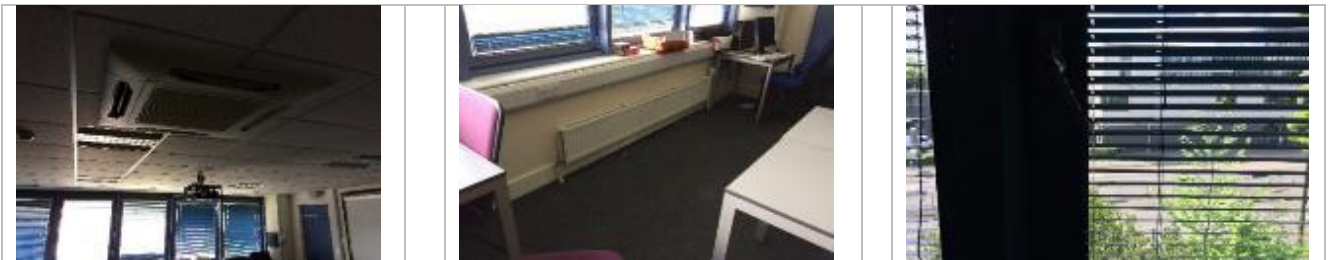
Typical classroom, with ceiling mounted split cooling unit, LTHW heating radiator. No mechanical ventilation is provided, this is achieved via openable window.

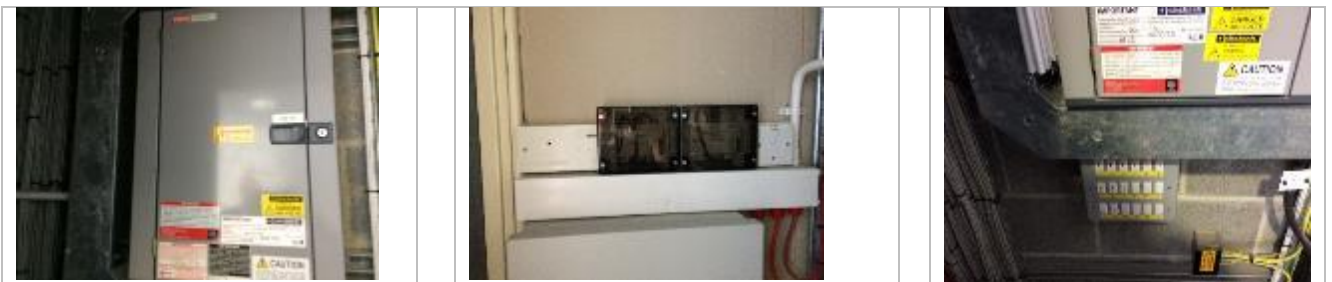
Typical electrical room housing DB serving floor.

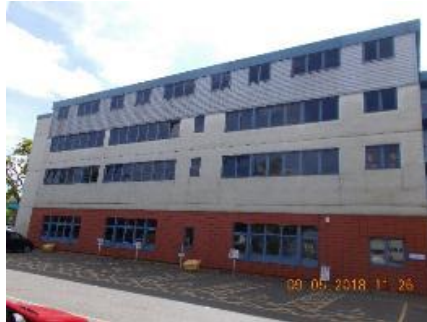
No significant structural defects noted. The roof is standing seam sheet metal construction, modern and in good condition. The flat roof areas believed to be single-ply membrane all noted to be in good order.

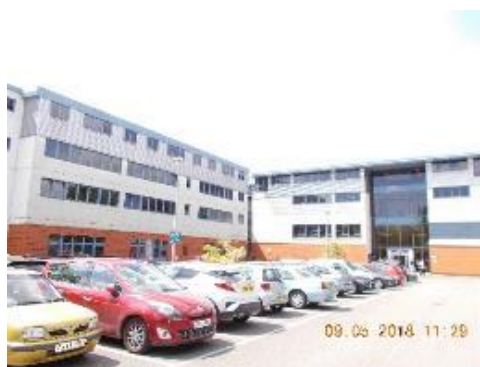
Windows and external doors in satisfactory condition.

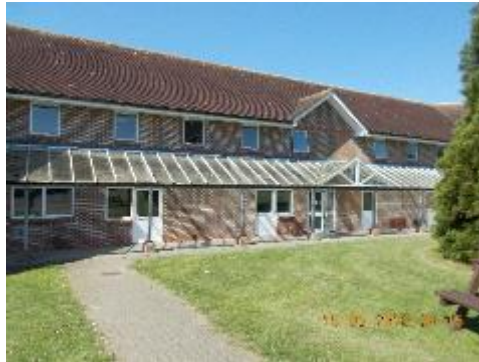
No significant structural defects were noted. Pitched hipped roofs with tiled covering noted to be in satisfactory condition, with some ad-hoc repairs and ongoing maintenance required.

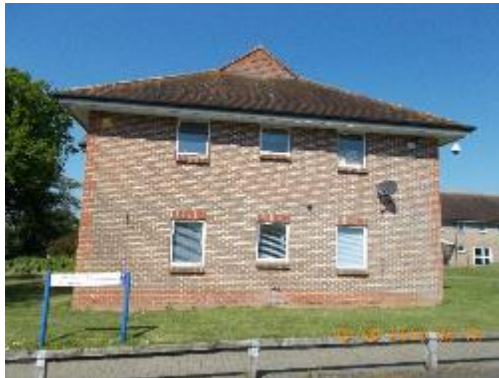
Windows and doors mostly in satisfactory condition.

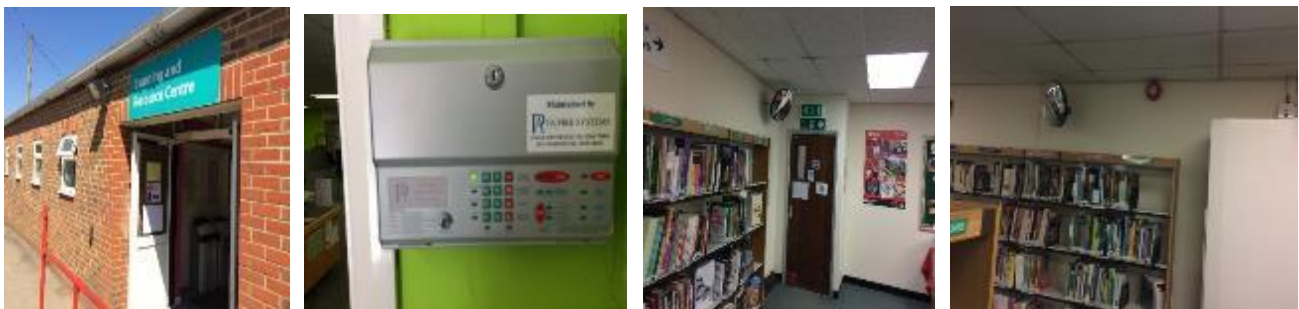
General FA panel and bell

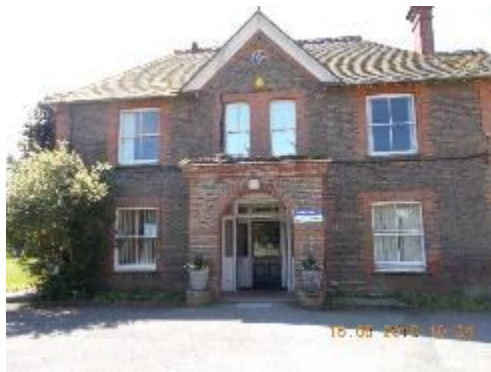
External doors in good order with some minor repair issues, single glazed timber framed windows are old but serviceable and will require regular cyclical maintenance if they are to be retained.

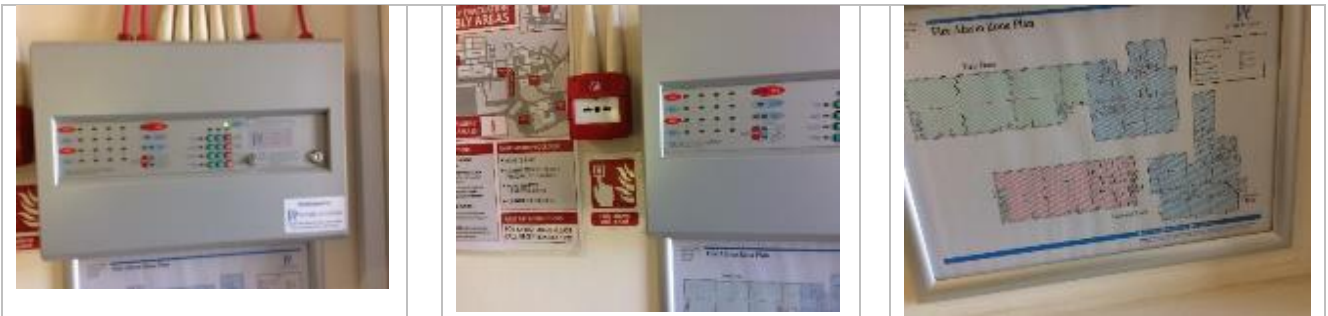
FA panel and zone plan

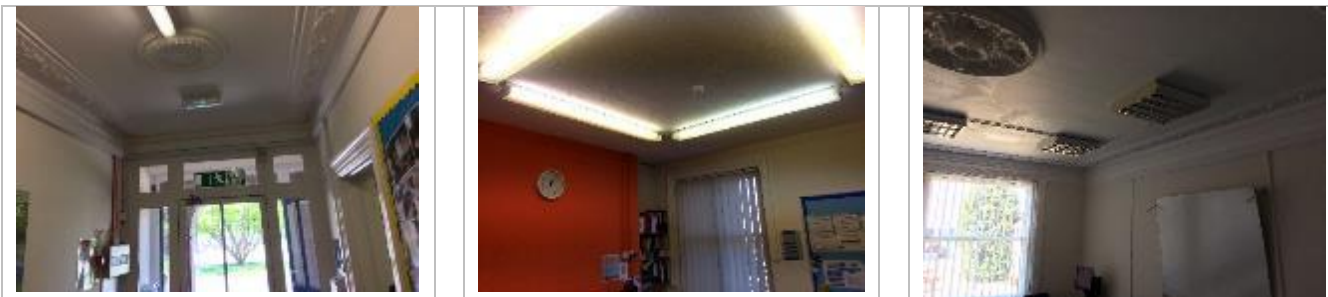
Typical lighting types

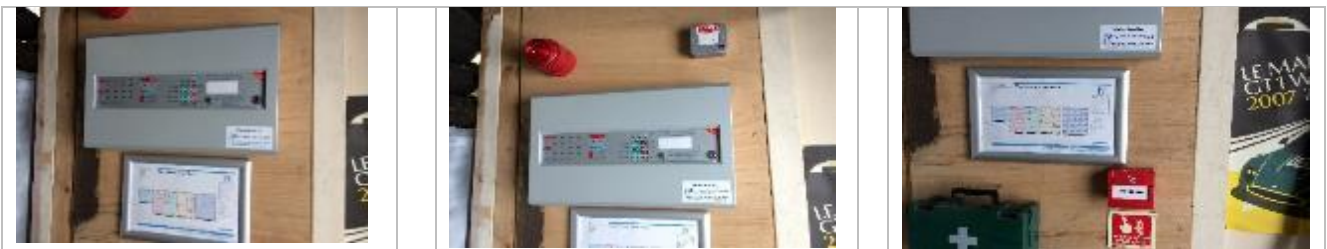
The workshops do not benefit from a fire detection system but instead have manual call points, to sound the alarm, located by the front pedestrian entrance doors to each workshop. It was also noticeable that there was no fire compartmentation between the workshops due to the nature of construction. Given the usage, materials and consumables present, the fire risk is considered to be high.

FA Panel and Zone Plan

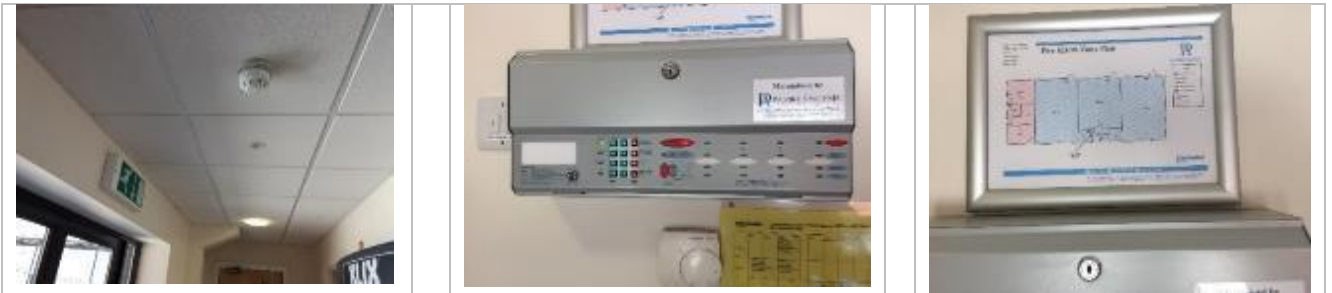
Typical PIR and FA detector, FA panel and zone plan

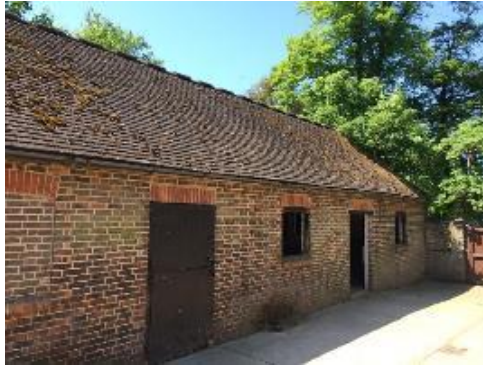
We noted spalling to brickwork and rot to traditional cut rafters and purlins of the roof structure. To be monitored and repaired.

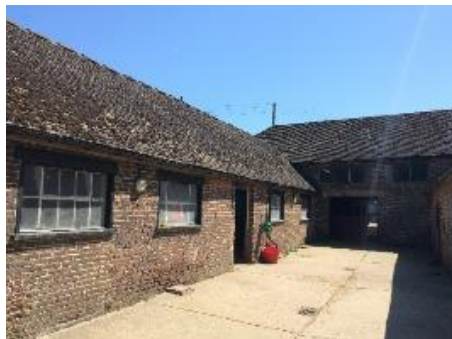
Pointed masonry finishes. Moderate condition.

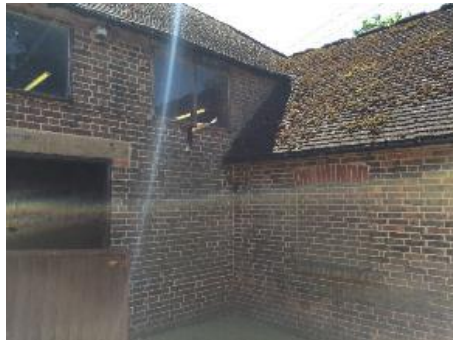
Single glazed windows in poor condition.

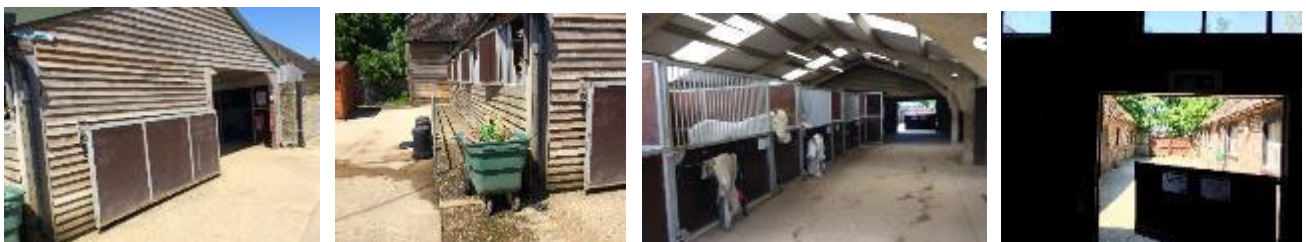
Stables

The IRS stables comprise the original barn and provides stable accommodation for livestock only and therefore the regulations are less stringent. There are fire exits, escape signage, and a hand bell fire alarm. Water is provided but a non-return valve should be installed to comply with current water regulations.

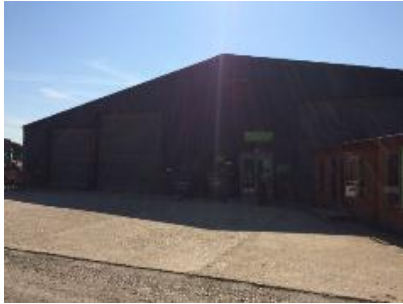
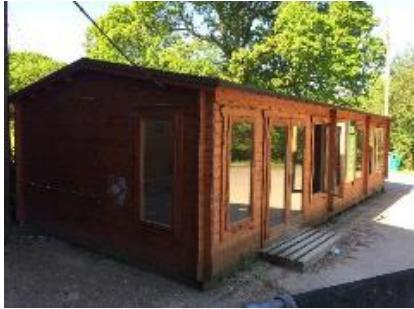
No significant structural defects noted. Fibre cement sheet roof in fair condition.

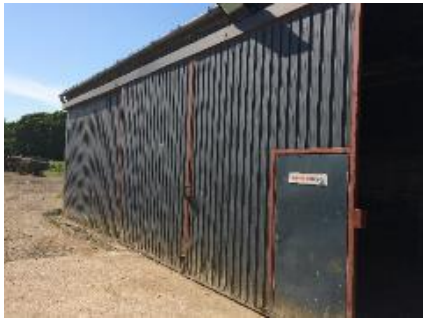
Metal sheet construction, in satisfactory condition.

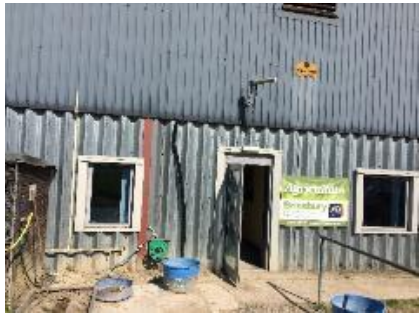
Aluminium framed doubled glazed windows and doors installed c2005 in good condition.

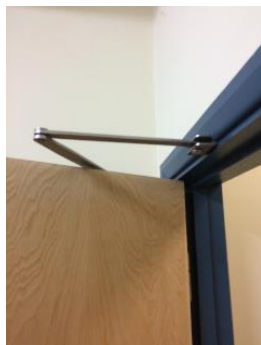
Internal doors are generally in serviceable condition.

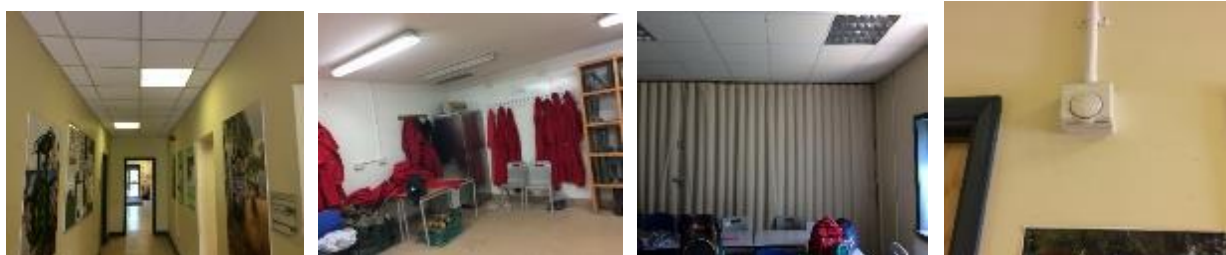
There is mechanical extract ventilation within the changing/drying room.

Typical corridor, changing/drying room, classroom lighting and Htg controller

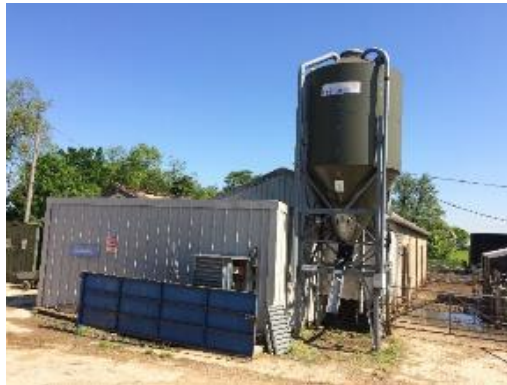
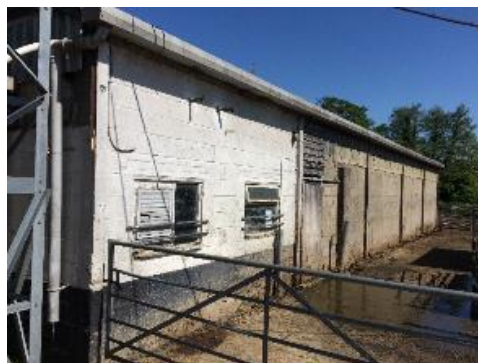
Fit for purpose as dairy / creamery only.

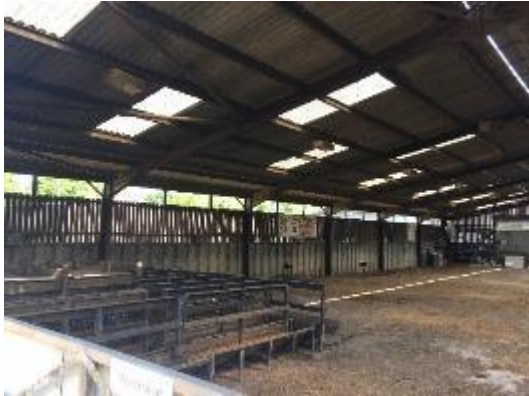
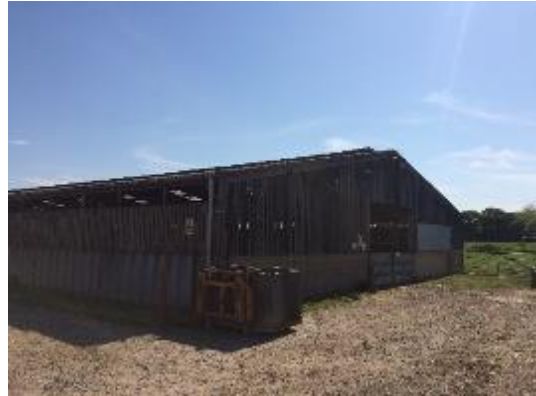
Fit for purpose as livestock store only.

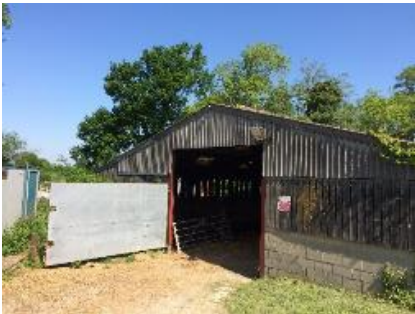
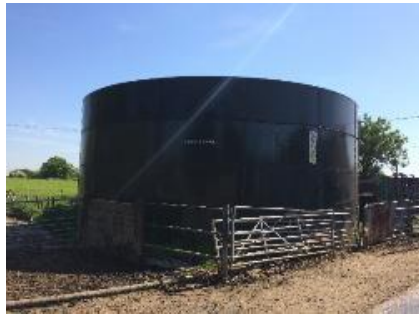
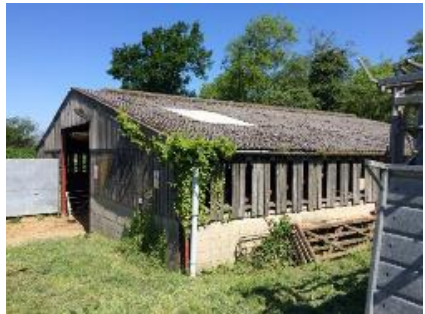
Fit for purpose as livestock store/silo only.

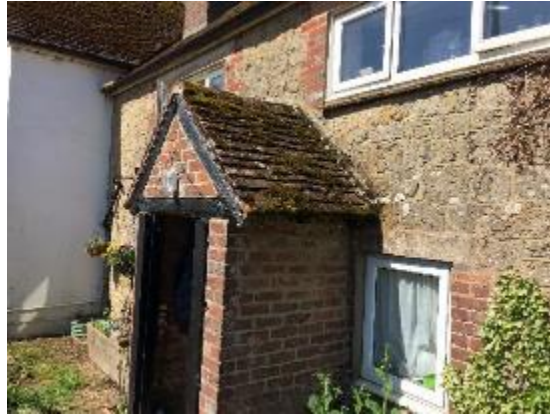
The Farm Cottage appeared structurally sound, although of some age. Only external access provided.

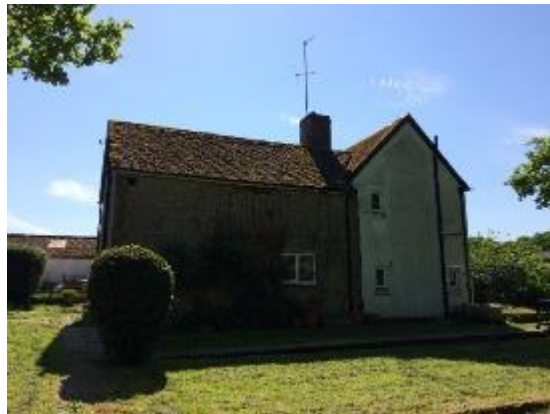
Roof of traditional pitched construction with tiled finish. Satisfactory condition, although would benefit from moss and debris removal to extend life.

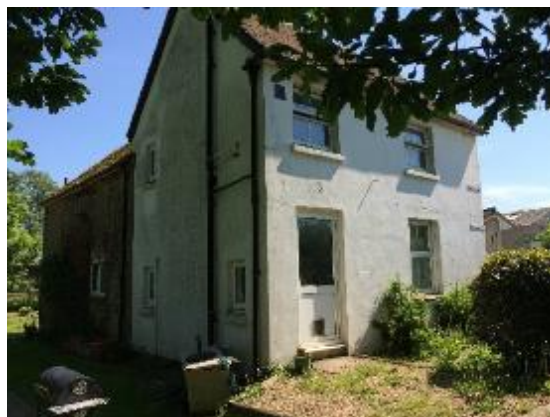
PVCu windows all in satisfactory condition.
